## STUDY OF THE PAINTED DOME OF THE CHURCH OF ARCHANGEL GABRIEL, CAIRO

This study was carried out in preparation for the conservation of the oil painted dome of Archangel Gabriel church located at Haret El Saqqayeen in Abdeen (Cairo). Stratigraphic, chemical and environmental studies were conducted to examine the painting technique and to assess the conservation state of the dome. The dome was imaged using Multi-spectral imaging and samples were collected from representative areas. Cross-sections were investigated by the means of scanning electron microscopy coupled with dispersive energy of X-ray spectrometer (SEM-EDS) and stereo microscopy. Fourier transformed infrared spectroscopy (FTIR) and gas chromatography-mass spectroscopy (GC/MS) was employed for the identification of the paint medium. X-ray diffraction (XRD) and the colorimetric measurements were conducted for characterization the differences of hues between the original and non-original pigments. As a part of the study, the environment within the dome was measured with data loggers and gas sampling. The results showed that the painted dome dates back to two different periods. The older paintings were applied before 1907

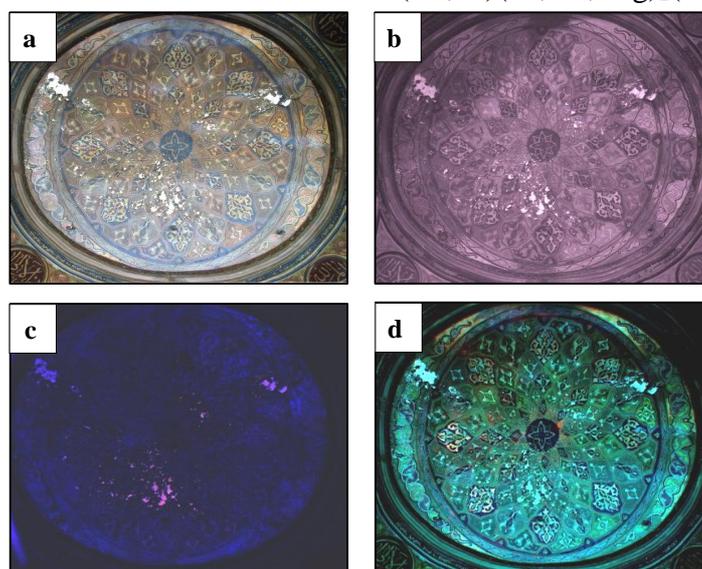
The Ultraviolet fluorescence (UVF) image characterized the signatures of Ismail Mahmoud and Mahmoud Bahgat who are the original painters of the dome with a date of 1907. Infrared reflected (IRR) and UVF images showed that the dome was heavily overpainted during the restoration interventions carried out in 1994. This is evidently detected in darker areas. Since the dome was restored in 1994 after the earthquake of 1992, some of the conservators signed their names with the date of restoration interventions, fig. (3). Colorimetric measurements of the brown over-painted on the original yellow showed a reduction of the luminosity and

yellowness ( $L=33.78$ ;  $a=14.5$ ;  $b=41.8$ ) than the original yellow paint ( $L=40.3$ ;  $a=9.44$ ;  $b=25.29$ ). EDS and XRD analysis showed that Burnt sienna brown pigment was painted over the original yellow ochre. EDS analysis of the dark green pigments (original and overpainting) showed the presence of elements Ba, Na, Fe, Cu, Si, Mg, Al, and Zn. This suggests that the original green earth (Fe, Na, Si, Al, Mg) overpainted by Copper-based pigment (Cu). Furthermore, analysis by XRD indicated that the presence of Malachite [ $\text{CuCO}_3 \cdot 2\text{Cu(OH)}_2$ ] was painted over the original green earth of Glauconite ( $(\text{Na, K})(\text{Fe, Al, Mg})_2(\text{Si}_4\text{O}_{10})(\text{OH})_2$ ).

Figure (3) Shows Multi-spectral images (VIS, IRR, UV, IRFC) of the overpainted areas applied to the original paints

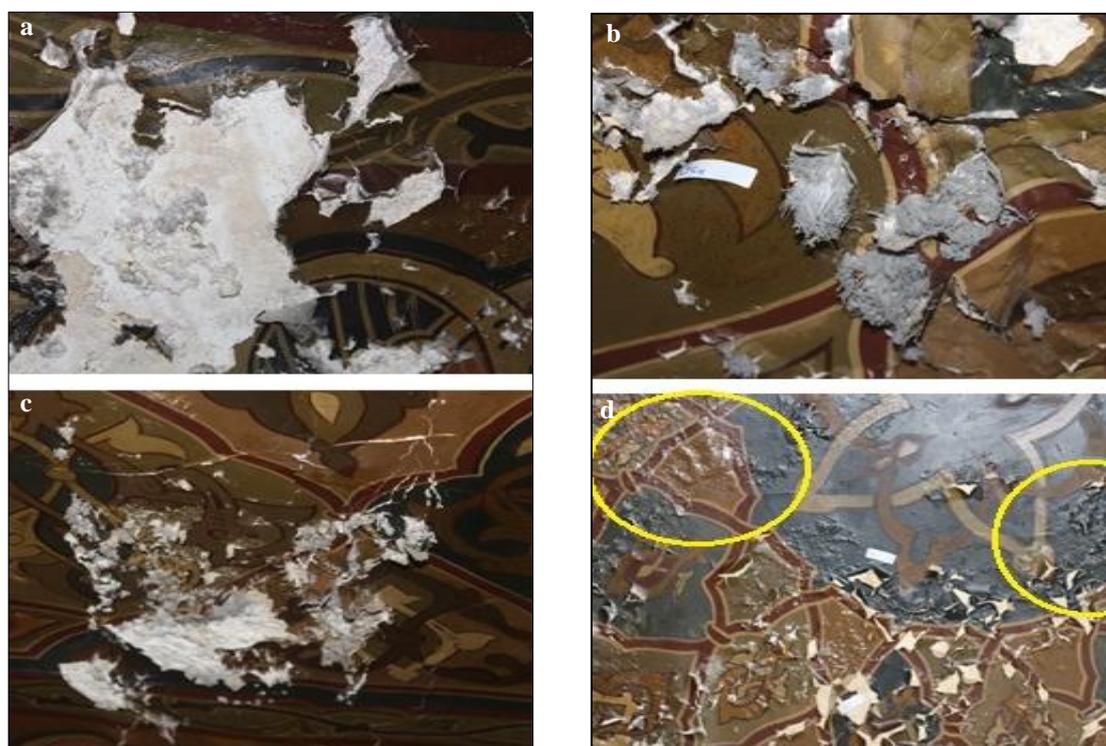
While the roof was isolated since the restoration interventions of 1994, the insulating materials show some deterioration now. This is increasing the likelihood of water infiltration from the roof to the painted surfaces causing salts dissolving from the construction materials. Then the dissolved salts migrate within the multilayered structure of the ceiling and crystallize between the layers creating mechanical pressure which leads to paint flaking, cracking and loss of cohesion of the support and the paint layers to completed loss in paints. SEM-EDS and XRD analysis of soiling revealed the presence of dust elements (Sodium

Aluminum silicates) which may promote the oxidation of pigments [17]. Furthermore, the leakage of rainwater from the roof with fluctuations of the temperature values between day and night and throughout the year could promote salt recrystallization in the ground (plaster) layers that were clearly detected in the form of fluffy and needle forms, fig. (5). Salt crystallization exerts mechanical pressure leading to loss of cohesion, cracks, flaking and complete loss of paint layers. SEM-EDS showed Sodium chloride salt (NaCl) which is associated with deliquescence at 75 % RH [18].

Figure (5) Shows **a.** paint loss and salt crystallization, **b.** & **c.** needle form of salt and paint flaking, **d.** brittleness of paint layer due to salt crystallization below the paint layer

church should be aired regularly by opening windows and doors during and after liturgies to allow pollutant air to escape. Consolidation of the roof with an appropriate insulating material is a significant step to protect the ceiling from water infiltration.

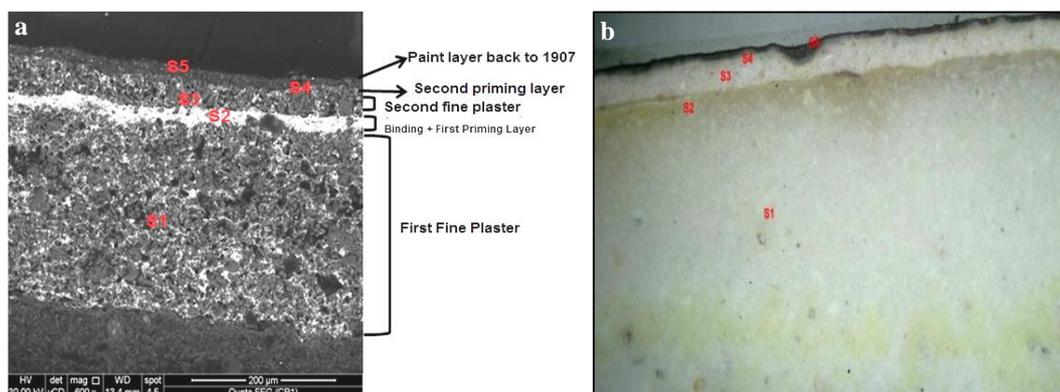
Microscopic investigations of various cross-sections showed that the stratigraphy of the ground layers was formed by four consequent layers that differ in their thickness, fig. (6). EDS analysis indicated that the ground layers are containing Ca, Ba and Zn with different concentrations of each layer. XRD analysis proved that they mainly consist of Calcite ( $\text{CaCO}_3$ ),

Barite ( $\text{BaSO}_4$ ) and Zinc Oxide ( $\text{ZnO}$ ). Finally, FTIR analysis of the ground layers demonstrated the presence both of organic and inorganic materials. Sulfates and Carbonates were easy to be characterized which might have been applied in a drying oil to create a less absorbent surface for painting.

Figure (6) Shows **a.** SEM image, **b.** microscopic investigation of the stratigraphy of 1907 painting
