ENVIRONMENTAL AND CLIMATIC HAZARDS AND THEIR IMPACTS ON THE CULTURAL HERITAGE OF EL-KHARGA OASIS, WESTERN DESERT, EGYPTIsmael, H.^{1(*)}, Abdel-Motamed¹, M. & Abbas, W.²¹Geography dept., Faculty of Arts, New Valley Univ., Kharga, Egypt²Geography dept., Faculty of Arts, Ain Shames Univ., Cairo, Egypt(*)E-mail address: hossam_geography@yahoo.com**Article info.****Article history:**

EJARS - Vol. 10 (2) - Dec. 2020: 135-152

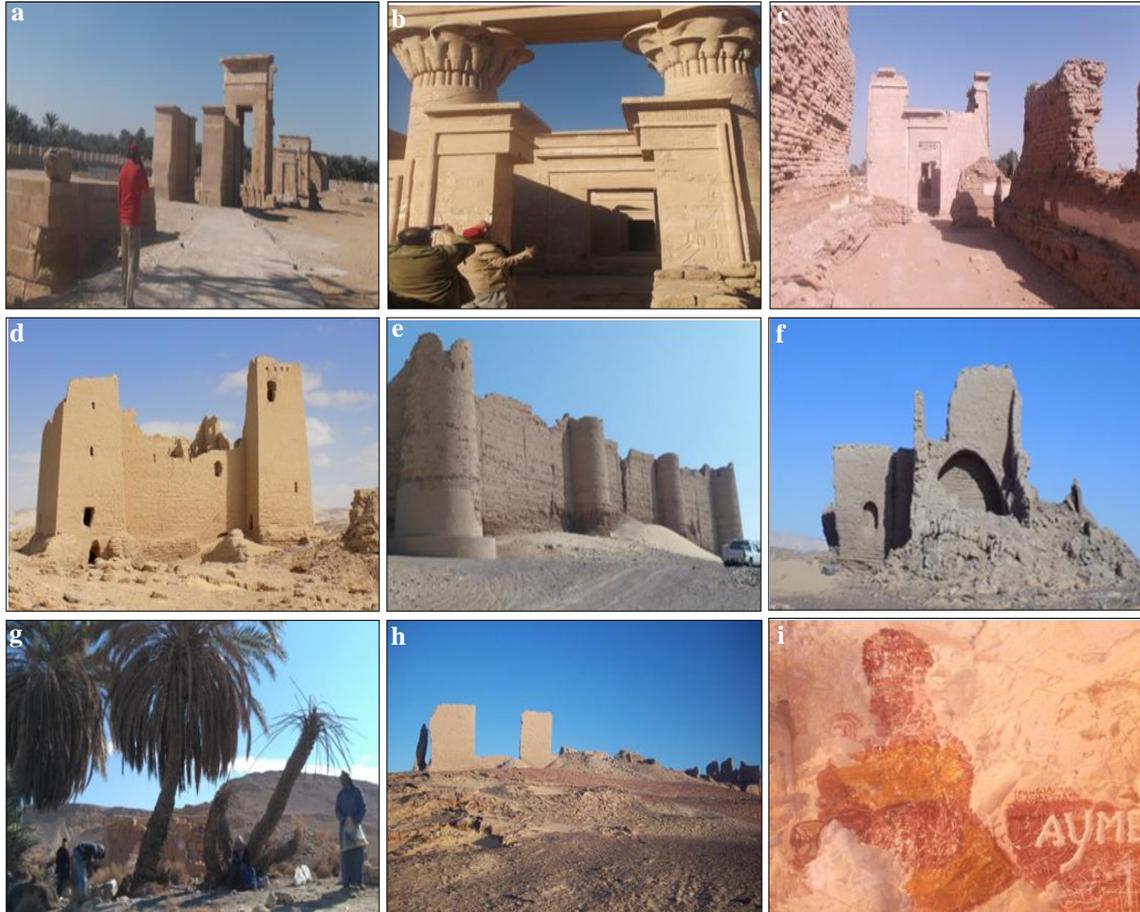
Figure (2) Shows samples of the archeological sites under investigation; **a.** Hibis temple, **b.** Qasr Dush temple, **c.** El-Ghwieta, **d.** Umm El-Dabadeb **e.** Deir El-Monra, **f.** Qasr El-Gib, **g.** Ain Amur, **h.** El-Nadours temple, **i.** Gabel El-tier

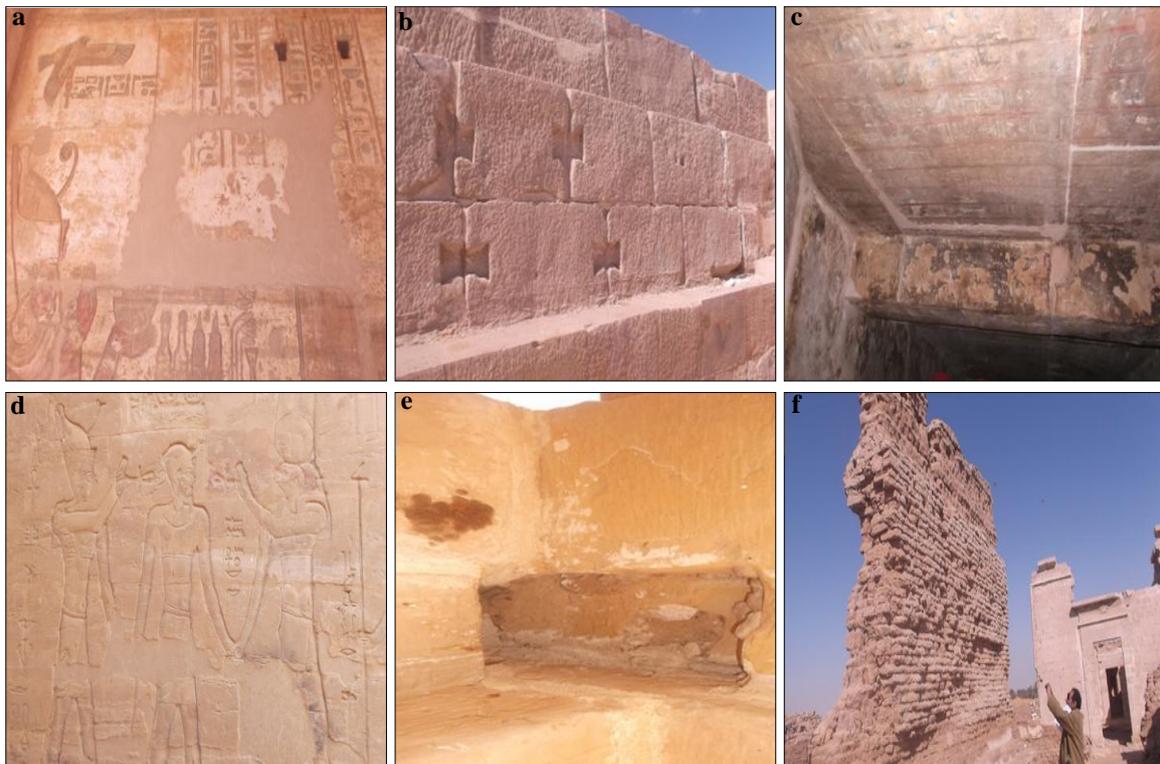
Figure (3) Shows different weathering forms at Hibis temple; **a.** loss of inscriptions, damping, bad restoration, **b.** anthropogenic impact, cracking, granular disintegration, **c.** salt efflorescence, contamination, loss of inscriptions and bad restoration, **d.** some damage categories affected sandstone of El-Ghwaieta temple, **e.** & **f.** some damage categories affected sandstone of El-Zayan temple

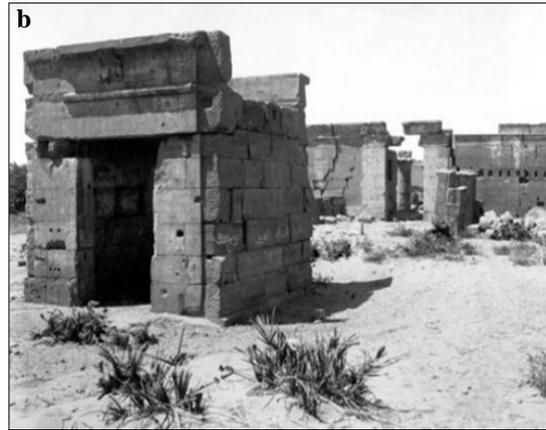
threat to the stability of the temple basis. The source of water seepage beneath is partly from an agricultural return flow, which affects the shallow groundwater table. The temple was severely damaged after 1823; it was restored by Émile Baraize. Unfortunately, the rising groundwater has weakened the foundations. The Metropolitan Museum's work at El-Kharga established a precedent for the study, fig. (4-a, b). The Continuous Partial Immersion at Hot and Cool Temperature (CPI-HT/CPI-CT) regimes had been conducted to imitate the climatic conditions dominating at El-Kharga oasis. The regime cycle is 24 h altering among HT (Temp. more than 40 °C and relative humidity less than 10%) and CT (Temp. down to zero °C and relative humidity less than 10%) every 12 h, and the stone bars are continuously partially immersed in 0.5 M sodium sulfate salt solution. The test has been extended to 30 cycles i.e. 30 days taking into consideration weighting and documenting the sample every 2 cycles to record the underground water effects over test progress. At the end of the test, the weight loss has been computed. The durability class and value of the original construction rock, reconstruction rocks, and the control rock samples has been determined using Barry diagram (1991) [27]. The extensive use of groundwater for domestic and irrigation purposes from natural springs and deep wells during successive periods led to the present-day lowering in the static levels to tens of meters below the oasis floor. To clarify this further, the frequency of climate change impacts on El-Kharga oasis has extended to the present-day climate and it can be observed that such impacts have been increased. In particular, the risk of groundwater fluctuation, and the accumulation of weathering forms on the walls of Hibis temple.

Figure (4) Shows **a.** & **b.** underground hazards affecting Hibis temple 1823(<http://www.metmuseum.org>).

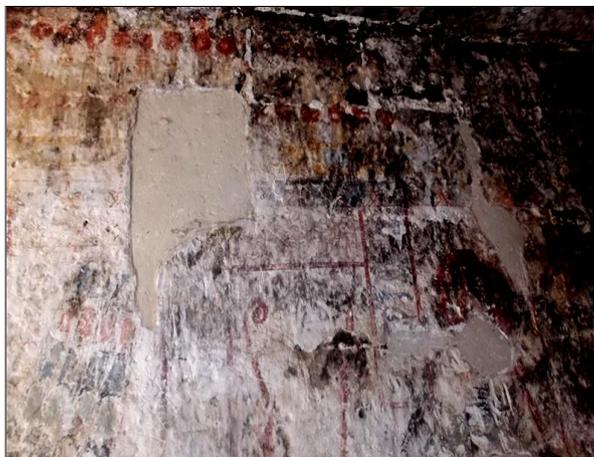
the same time, the salts hold by the building itself can result in inflorescence and some other effects damaging the chemical and physical structures of the walls. Increasing relative humidity motivates microbiological deterioration and led to the presence of living or decayed microorganisms such as algae, lichens, moss, and fungi on the stone surface, sometimes get feeding by the metal found in the scree or stone. Also, the disintegration of the mortar used in jointing the stone wall. Eroded parts of the soft stone surface regularly washed by rain or underground water seepage and missed the wall color, text, and graph, fig. (6).

Figure (6) Shows the humidity impacts on the walls of archeological sites under investigation

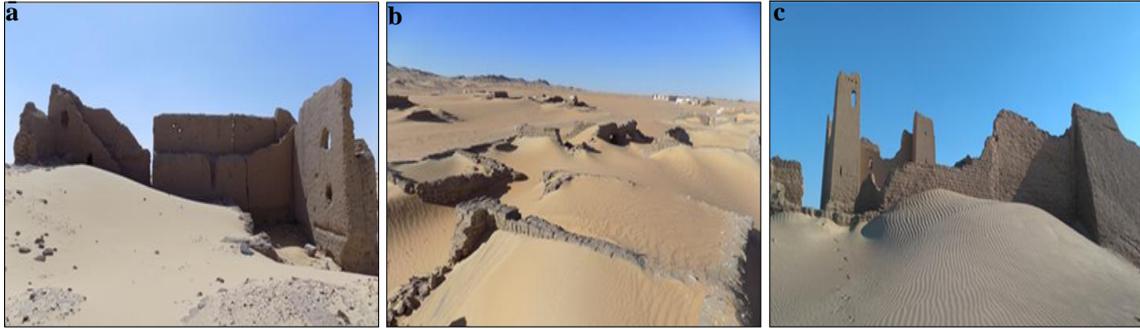
due to speed of the wind. It can also be noticed that this analysis is consistent with the sand dunes hazards on the archeological sites in the study area. The impacts of wind and the consequent encroachment of sand dunes hazards are highly shown on all building stones (temples, cemeteries, and castles) in El-Kharga oasis. The wind blows from the north-northwest direction with moving capacity to drift sand dunes from the North, which is a common phenomenon encroaching upon archeological sites; particularly, which have been built on a hilltop 100-140 m. in hyper-arid climate and exposed to the wind without any obstruction such as Al Tarakwa, Ain El Gib, Qasr El Somira and Umm El Dabadeb, fig. (7).

Figure (7) Shows the wind impacts on the archeological sites under investigation

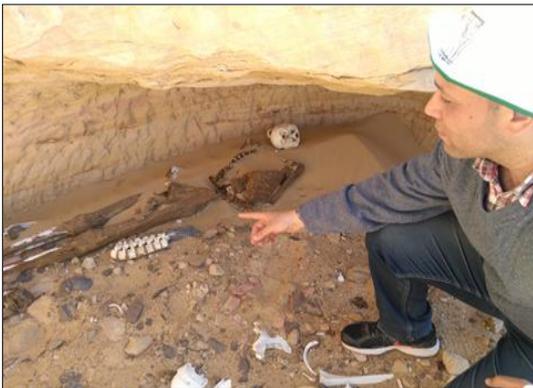
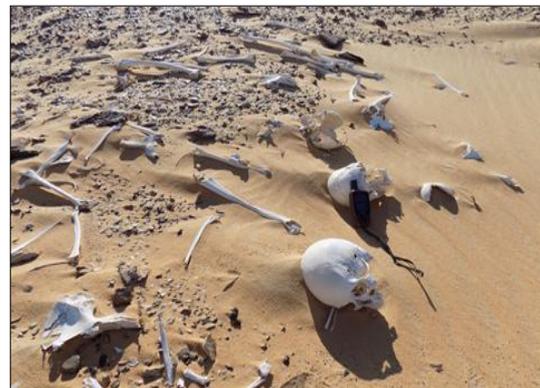
makes this an impossible task at every site. During the field study 2018, skulls from El Trakwa and El Dabashya showing what can happen to ancestors when a site is looted. A quick inspection of many field studies reveals that looting and wanton destruction of El-Kharga's tangible cultural heritage have been widespread, because the archaeological sites are unprotected and spread over large areas, the vast number of sites in El-Kharga makes this an impossible task at every site. During the field study 2018, skulls from El Trakwa and El Dabashya showing what can happen to ancestors when a site is looted. Also, it can be observed that the temples in Ain Amour, Umm El Dabadeb and Dabashya have been destroyed by using heavy construction equipment such as a loader, fig. (8).

Figure (8) The Human-induced hazards on the archeological sites under investigation
