CHARACTERIZATION OF HISTORICAL MORTAR USED IN LOOM
FACTORY SITE AT ABYDOS

Osman, A.¹, Bartz, W.² & Kosciuk, J.³

This paper aims to characterize historical mortars taken from joints in Loom Factory site at Abydos Sohag (Egypt). This characterization includes their composition and technology, their state of preservation as well as provides a guide for their possible conservation process. A multidisciplinary approach has been adopted for investigations. Samples were investigated by means of visual inspection, polarizing microscope (PM), scanning electron microscope (SEM) coupled with energy dispersive X-ray unit (EDX), powder X-ray diffraction (XRD), hydrochloric acid (HCl) attack, sieving analysis, deferential thermal analysis (DTA-TG) and physical tests. Obtained results allowed to fully characterize mineralogical, chemical, and mechanical properties of selected mortar samples. They show a similarity of type, and binder/aggregate ratio. This similarity can be attributed to one building phase using the same source of materials.

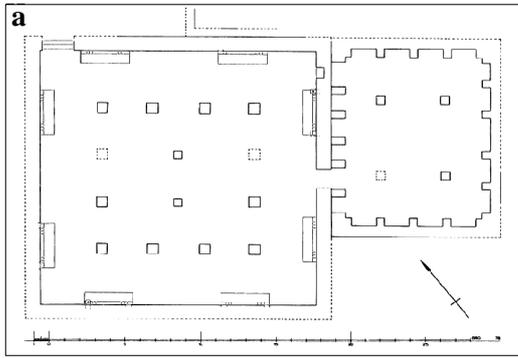
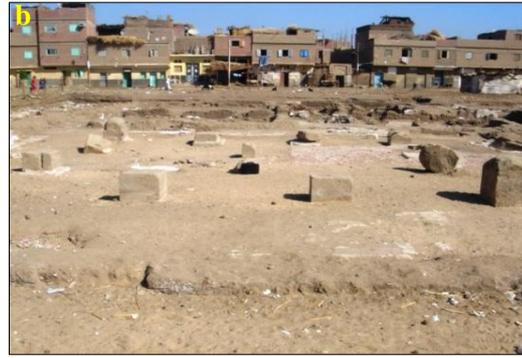
Figure (1) Shows **a.** plan of the loom factory site (After Farag, 1983), **b.** general view of the site.

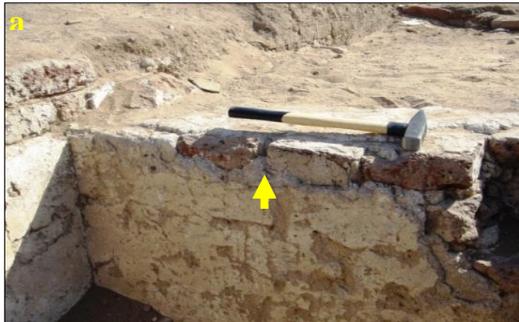
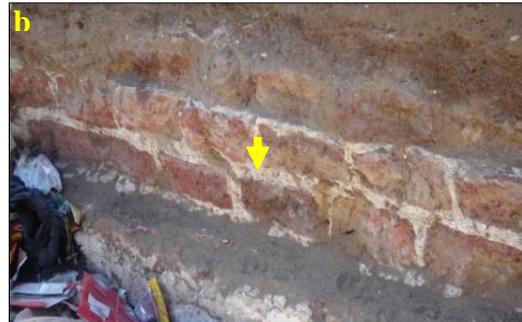
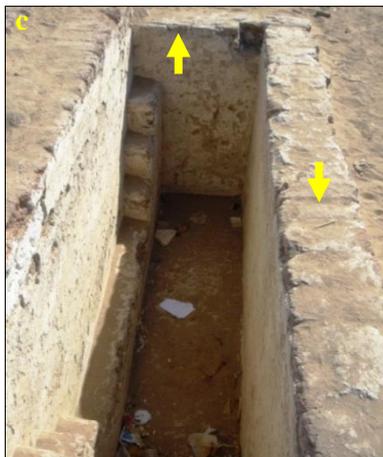
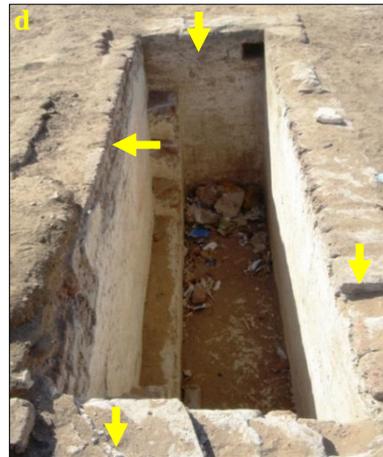
Figure (2) Shows locations of samples **a.** AN1 the southern wall of the site, **b.** AN2 from the western wall of the site, **c.** AN3 from 1st loom pit, **d.** AN4 from 2nd loom

Since the building is relatively small, only few representative samples were taken from different remnants of walls at four locations, which are still visible on the site. All samples represent jointing mortars and were carefully taken with use of hammer and chisel, from the western and southern walls of building and from the unearthed two loom pits. The map of the excavated site and locations of samples are presented in fig. (1-a, b) & fig. (2-a, b, c, d). These samples have been prepared to be investigated by the naked eye in terms of color, state of preservation, and visible aggregates. Thickness of samples was measured already in situ and rechecked once more in the laboratory using digital calliper. In addition, polished sections (ca. 45 μm thick) were observed by use of a stereomicroscope Zeiss STEMI 2000-C equipped with digital camera Canon Powershot G10. Thin sections of intact piece of each location were prepared in a similar way, but with thinner slices (thickness of ca. 30 μm) for petrographic analysis [3]. They were examined with transmitted light polarizing microscope (Zeiss Axiolab Opton) equipped with Canon Powershot G2 digital camera coupled to the microscope through an eyepiece adapter. Few grams of each sample, bulk as well as sieved (0.063 mm) and enriched in binder one [4, 5] were prepared for powder X-ray diffraction analysis. Both groups of samples were analyzed with Siemens D 5005 powder diffractometer, using $\text{CoK}\alpha$ radiation, at scanning speed $2\theta=2.0^\circ/\text{min}$ and 30 kV, 20 mA current [6]. Different mineralogical phases were identified using PANalytical X'pert high score plus software. For microstructural analysis, samples were examined by scanning electron microscope SEM-VEGA LSU TESCAN, which was equipped with an X-ray detector (EDX) (Oxford Inca-pentaFETX3 detector). Binder/aggregate

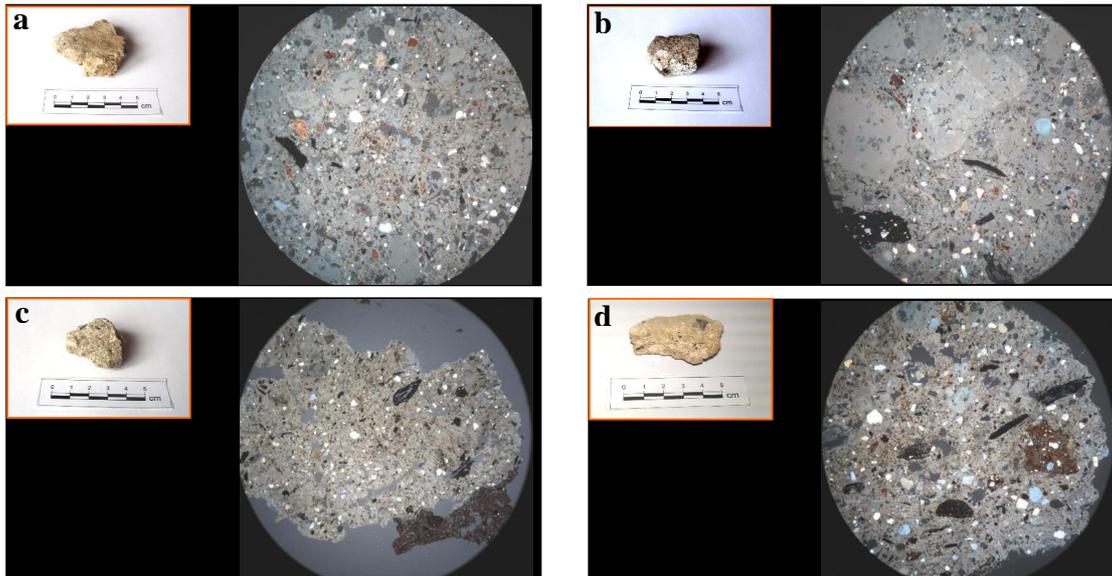
Figure (3) Shows **a.** sample AN1 from the southern wall (on the left) and photomicrograph of polished section (on the right) showing presence of lime lumps and few small brick fragments, **b.** sample AN2 from the western wall of the site and photomicrograph of polished section showing big lime lumps as well as presence of charcoal pieces, **c.** sample AN3 from the 1st loom pit (on the left) and photomicrograph of polished section (on the right) showing small amount of quartz, **d.** sample AN4 from the 2nd loom pit (on the left) and photomicrograph of polished section (on the right) showing presence of quartz grains, charcoal pieces as well as rather big fragment of red brick.

Results of examination by naked eye and stereomicroscope revealed similarity between all samples in terms of grayish color, presence of various and distinct components such as charcoal, lime lumps, organic matters, and brick fragments. All of them represent also relatively good state of preservation. Thickness of all samples is similar ranging from 20.2 mm for sample AN2

that belong to the western wall of the site, up to 23.0 mm for sample AN4 belonging to a wall of one of the loom pits. Small amount of quartz grains was observed in all samples. The investigation results of the studied samples by naked eye and stereomicroscope are summarized in tab. (1). In addition, the samples' features and their polished sections are shown in fig. (3-a, b, c, d).

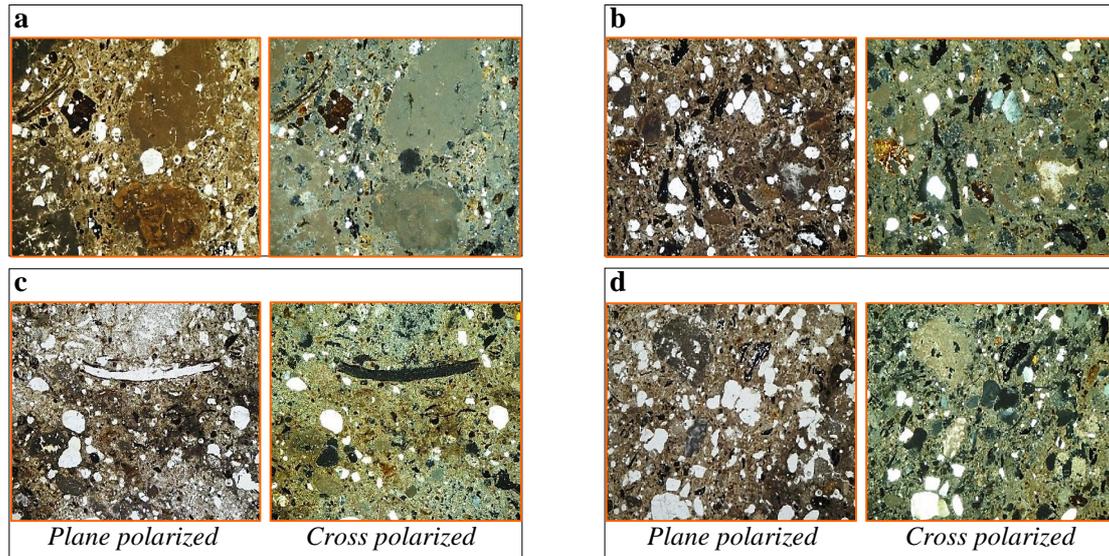
Figure (4) Shows thin section micrographs under *plane polarized* (left) & *cross polarized* (right): Field of view is ca. 6 mm **a.** sample AN1 Lime lumps up to 4 mm, **b.** sample AN2, **c.** sample AN3, **d.** sample AN4

The results of the petrographic analysis revealed similar mineralogical components for all samples, including rounded quartz grains as major constituent of their aggregate. Some of them were thermally transformed, strongly cracked, healed and surrounded with thin silica glass film. This feature is typical for sample AN1 that belongs to the southern wall. In addition, angular fragments of limestone and abundant amount of large lime lumps were identified, reaching up to 4 mm in diameter, fig. (4-a). Brick fragments are less abundant, but occurring as a subordinate constituent in all samples. Binding mass is not homogenous consisting of micrite as well as lime lumps. Charcoal is present and characteristic for sample AN1, while fresh (i.e.

not pyrolyzed) organic matter (with well visible structure of wood) is less abundant. Cracks within the binder filled with secondary weathering product (gypsum) were also observed. Uncommon poly-crystalline grains of calcite were observed in sample AN2, fig. (4-b). Some of them are partly calcined; their primary carbonate crystals are replaced by micrite. In addition, the presence of some other lithic grains of various rocks such as granodiorite, and siliceous sedimentary rock (cherts) were identified. Sample AN3, fig. (4-c) differs a little in comparison to other samples, being depleted in limestone fragments and lime lumps showing blurred boundaries with surrounding binder mass. As accessory minerals amphibole, garnet, K-feldspars

(perthite, microcline), plagioclase, glauconite and epidote were found in sample AN1. In addition, sparse biotite, which is strongly weathered to secondary chlorite was detected, as for sample AN2, amphibole, zircon, pyroxene, feldspars,

and epidote were detected, while sample AN3 show amphibole; plagioclase, weathered glauconite as well as fragment of volcanic rock. Biotite, K-feldspars, epidote plagioclase, and amphibole were identified in sample AN4, fig. (4-d).

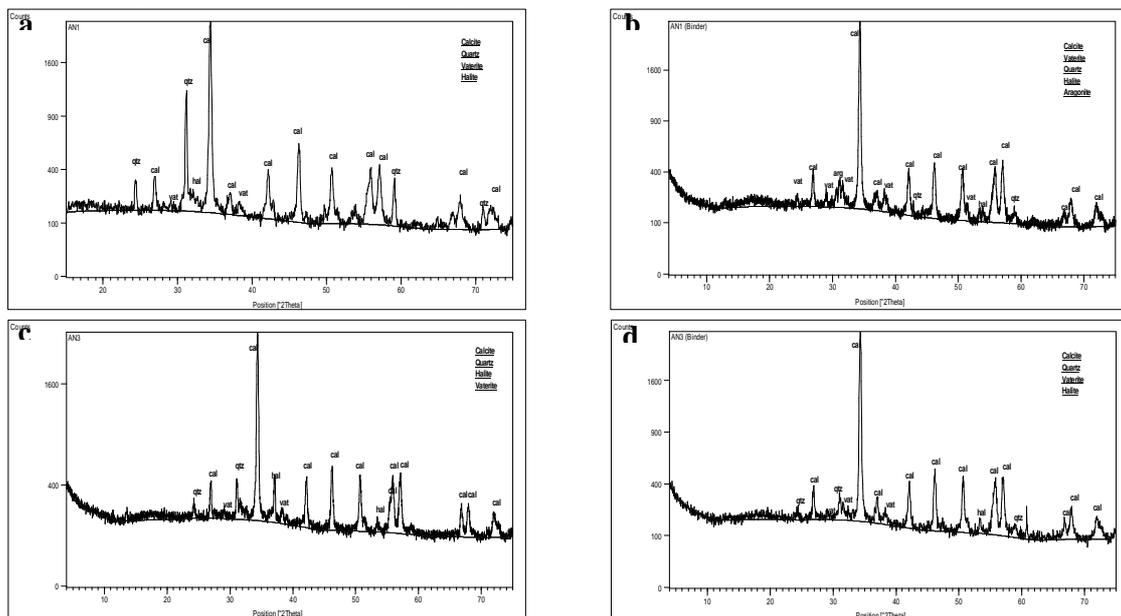
Figure (5) Shows XRD pattern of AN1 samples **a.** bulk sample, **b.** fractions rich in binder & AN3 samples, **c.** bulk sample, **d.** fractions rich in binder.

X-ray diffraction results of both bulk and binder samples are showed in, fig. (5-a, b, c, d). For bulk samples (AN1, AN3), obtained results revealed calcite and quartz are the two main phases. Vaterite and halite are present as minor phases. The second group i.e.

mortars AN1 and AN3 enriched in binder revealed calcite and vaterite as main phases in both samples. Small amount of quartz was present as remnants of sieving in both samples. In case of binder fraction of sample AN3, aragonite was detected too.

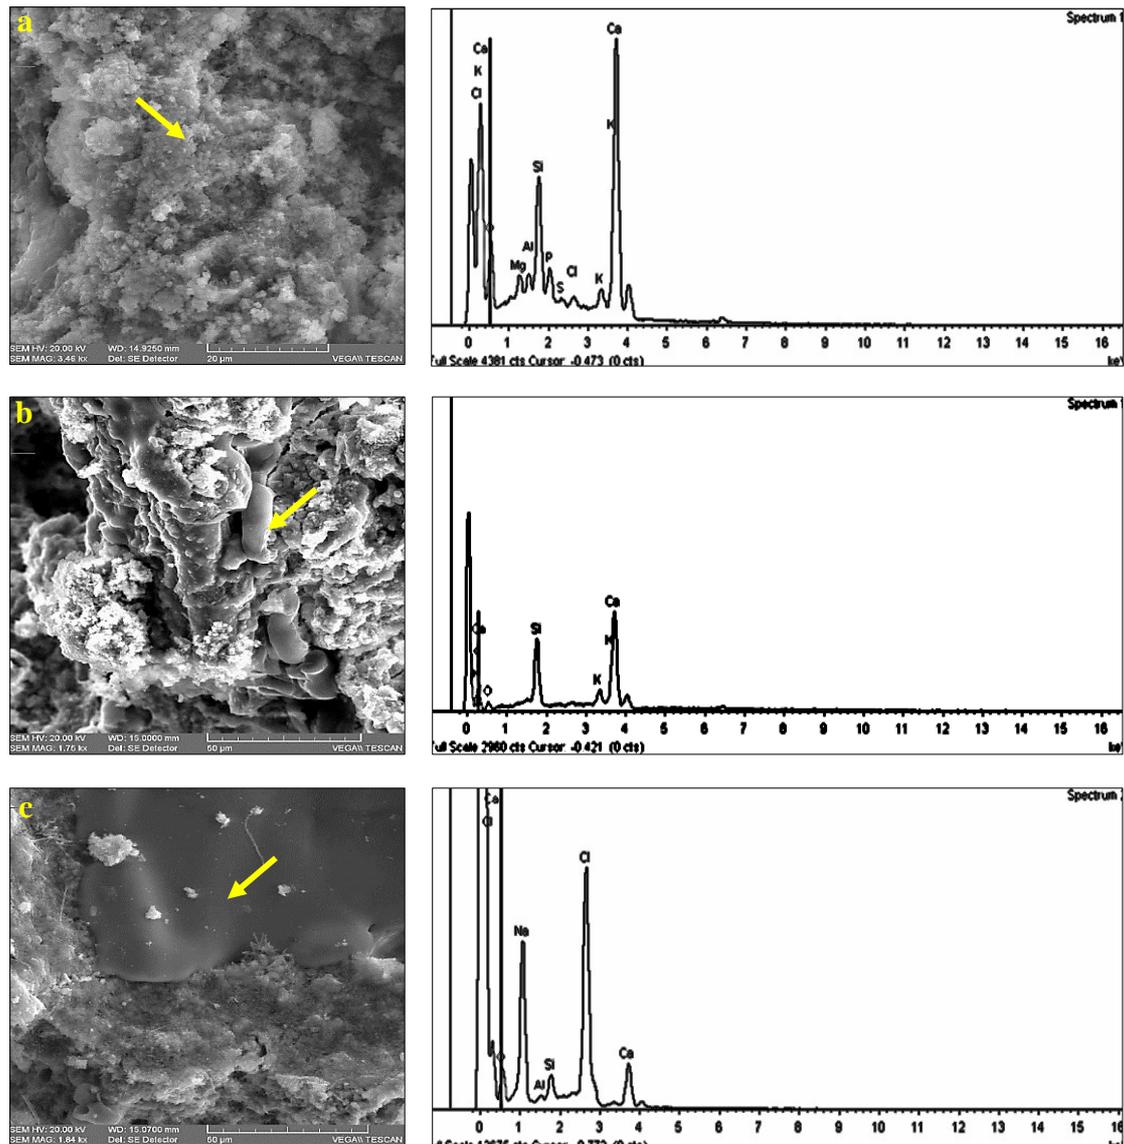
Figure (6) Shows SEM Microphotograph and EDX a. analysis for sample AN1 bulk sample, b. analysis for sample AN2, c. analysis for sample AN3

SEM/EDX observations of three mortars from Loom Factory site revealed various composition of a binder. Calcium is its main component, however aluminum and silicon occur in minor amounts, fig.

(6-a, b) especially in samples AN1 and AN2 respectively. Some samples (mainly AN3 from one of the loom pits) exhibit high content of sodium and chloride, fig. (6-c).

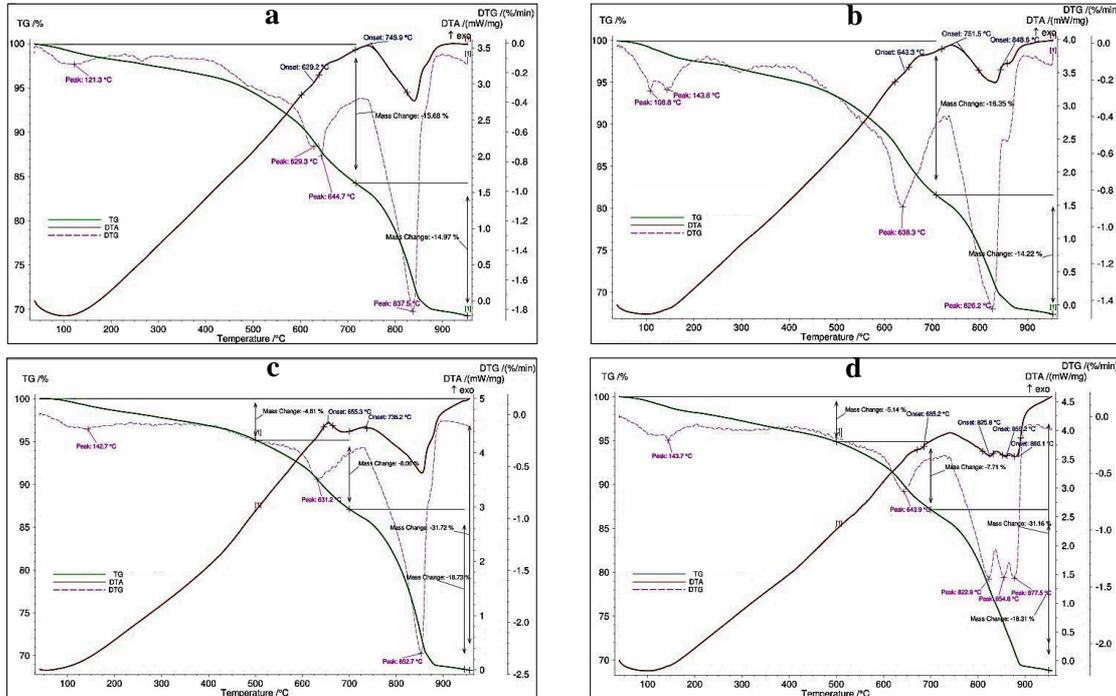
Figure (7) Shows DTA and TG curves of samples **a.** AN1, **b.** AN2, **c.** AN3, **d.** AN4.

The results of this technique reveal similar patterns of DTA/TG curves. Sample AN1 (the southern wall) reveals endothermic peak at 121.3 °C related to possible presence of secondary salts (gypsum). Carbonates show distinctive endothermic inflections at 629.3 °C and 837.5 °C, fig. (7-a). Sample AN2, fig. (7-b) (the western wall) shows two endothermic peaks at 108.8 °C, followed by 143.6 °C referring to presence of secondary product (double step dehydration of gypsum). Decomposition of carbonates was recorded at

638.3 °C. Sample AN3, fig. (7-b) (the first loom pit) has also two endothermic peaks, the first at 142.7 °C indicating presence of possible secondary products, and at 631.2 °C corresponding to the release of CO₂ from calcium carbonates. Sample AN4 (the second loom pit) has DTA/TG curves similar to sample AN3, with two endothermic peaks at 143.7 °C and 643.9 °C, fig. (7-d). All samples have similar total weight losses and very close percentages of carbonates contents as presented in tab. (4).

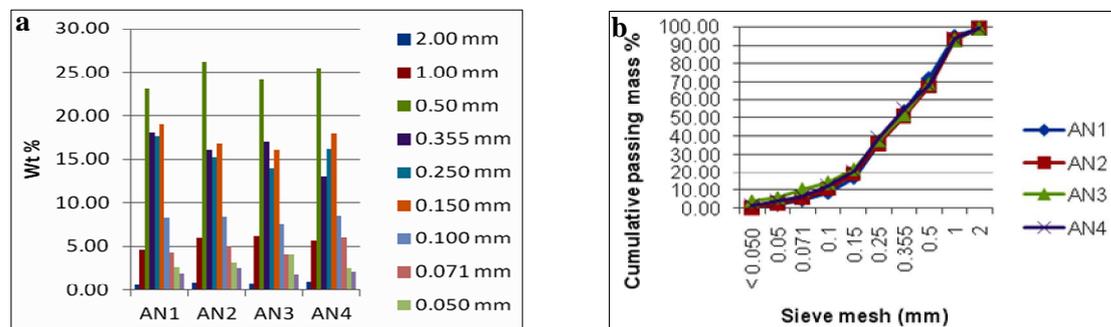
Figure (8) Shows **a.** Grain size distribution of mortar samples, **b.** Cumulative percentage curve for mortar samples.

Grain size distribution results, fig. (8-a) have revealed that mortar samples of Loom Factory have similar distribution of grain size. The most abundant fraction proportion for all samples is 0.5 mm with percentages

23.10 %, 26.19 %, 24.14 % and 25.49 % for samples AN1, AN2, AN3 and AN4 respectively. Cumulative curves for all samples from Loom Factory site are almost identical, fig. (8-b).
