INPUT OF THE TECHNICAL IMAGING FOR THE STUDY OF WALL PAINTINGS: EXAMPLE OF A LINTEL (TOMB OF KING TAKELOT I AT TANIS-SAN EL-HAGAR, SHARQEYA, EGYPT)

EJARS – Vol. 12 (1) – June. 2022: 73-87

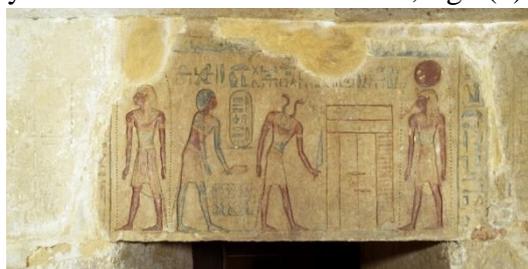
VIS image, fig. (2) shows the conservation state of the lintel and its decor. It appears to be in three parts. The main part is central, and two cracks patched with mortar that have an oblique direction separate it from two smaller blocks on its left and its right. The central and the right blocks have a general light brown ochre color. The surface aspect of the left block is beige. It is different from both others as its color is lighter and more granular. Its response under UV also is different as it has a light yellowish and clear fluorescence, fig. (3).

Figure (2) Shows VIS image of the lintel of Takelot I's tomb entrance; dimensions of the lintel in its unbroken part are 1.45-1.60 m in length and ~0.65 m in height.

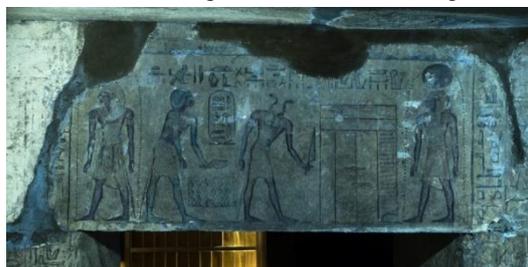
Figure (3) Shows UVf image of the lintel of Takelot I's tomb entrance; dimensions of the lintel in its unbroken part are 1.45-1.60 m in length and ~0.65 m in height, the left block fluoresces in a yellowish tint.

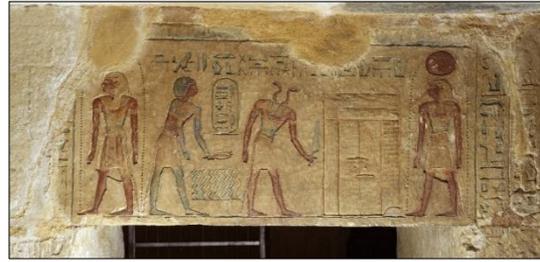
Figure (5) Shows RAK image of the lintel of Takelot I's tomb entrance; dimensions of the lintel in its unbroken part are 1.45-1.60 m in length and ~0.65 m in height. *The raking light lights up the lintel from the bottom and underlines the relieves such as surfacing tool marks, engravings or blisters.*

image. The depth map and RAK images of the lintel, figs. (3 & 4) allow better highlighting the degradations that led to the deformation of the surface: *) some parts of the surface shaping and the engraving seem worn because they are not very visible, especially in the middle and in the lower part where the engraved door; *) the lintel surface is locally significantly degraded; it leads to the disappearance of the engraved parts and shows a strong roughness on the side parts in contact with the underlying masonry that results from a granular disintegration; *) the restoration mortars that fill-in the gaps are slightly set back from the surface of the stone block; they are also strongly degraded on the right upper part of the lintel because of an in-progress granular disintegration and white efflorescence; *) missing parts affect the mortar on the left part of the lintel and white efflorescence cover it when it is in contact with the original engraved stone; *) the central part of the lintel seems to be broadly less affected by the deformations even if a few blisters are locally visible on its right part. The RAK and depth map images, figs. (4 & 5) make it indeed possible to highlight the blisters. This phenomenon appears to be active, as the blisters are on different steps of formation, from the bulging to their bursting. The μ VIS image of the blisters that have partially burst, fig. (8) shows that the exposed stone is yellowish. The surficial thin red pictorial layer ($<100\ \mu\text{m}$) is on a whitish layer which locally shows a yellowish color of the exposed stone surface. It seems to be the detached part of the surficial stone. The whitish layer appears to be of the same nature as the stone and is attributed to the presence of calcite. The whole discovered part of the blisters because of the loss of the superficial materials has a shiny appearance and locally presents a residue of greyer material that could result from the combination of salts and dust. The μ VIS image of the burst blisters, figs. (8 & 9-a) shows also a discontinuous and grey to black line between the whitish “layer” and the grey to yellow

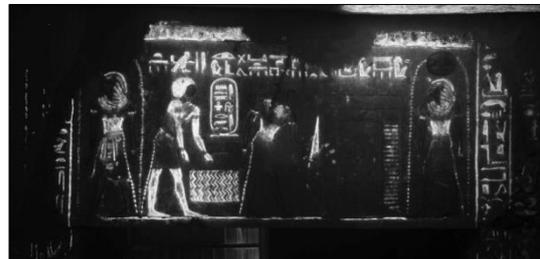
Figure (6) Shows IRL image of the lintel of Takelot I's tomb entrance; dimensions of the lintel in its unbroken part are 1.45-1.60 m in length and ~0.65 m in height. *The bright luminescence is attributed to the presence of Egyptian blue.*

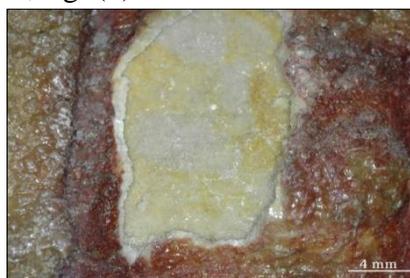
surface: it is a shadow due to overhead lighting and it indicates a disjunction that is discontinuous under the residual part of the blister. Nevertheless, it was not possible to determine the extent of this detachment in-depth. The discovered surface shows a high roughness. The micro-reliefs that are visible on the surface of the blister could be attributed to small forming blisters (appearing in a green-to-green yellowish color in the center of fig. (9-b)). The discovered surface is quite bright, figs. (8 & 9-a); this corresponds to white spots in the image and may result from reflections on different calcite crystals faces. The excavation of the blisters often is irregular. The digging is all the more important of the layer supporting the painting no longer is present and the remains of the blister have the highest altitude, fig. (9-b). VIS image, fig. (2) shows that the entire lintel has a yellowish color and is darker in its central part. A light grey-bluish fluorescence is mainly visible in the restoration mortar or on its periphery; these areas show a white colour on the VIS image. Some areas of the right have a bluish grey fluorescence, fig. (10-a). A part of them is allocated to splashes and lime milk run. The other part with a rectangular design corresponds to surface cleaning tests, fig. (10-b). Surficial white parts locally appear as veils under UV in a diffuse way or in clusters. These observations under digital microscope show that these clusters are made up of relatively elongated geometrical grains. Last, the red layer has a glossy and thickened appearance, fig. (8).

Figure (8) Shows μ VIS image of a blister (lintel of Takelot I's tomb entrance), the exposed stone is yellowish and The surficial thin red pictorial layer ($<100\ \mu\text{m}$) is on a whitish layer that seems to be the detached part of the surficial stone.

blisters affect the lintel at different evolution steps. Their formations are supposed to be the consequence of crystallization-deliquescence cycles of soluble salts beneath the surface [48]. Due to the repeated wet-dry cycles, the salts lead to the formation of a vesicle and then to its bursting with a loss of material and a hollowing out of the affected area [16]. The edges of the resulting holes show that the degradation leads to the separation the surficial part of the stone on which stays the pigment layer from the rest of the lintel. If IRfc gives information on the nature of salts as sulphate or chloride based-compounds, UVf image also gives information on the nature of these secondary materials, fig. (3) such as the surficial white veils that appear to be mad of salt crystals of undetermined nature.
