THE STONE BLEEDING PHENOMENON AFFECTING SOME SANDSTONE INSCRIPTIONS IN THE KARNAK TEMPLES

EJARS – Vol. 12 (2) – Dec. 2022: 175-186

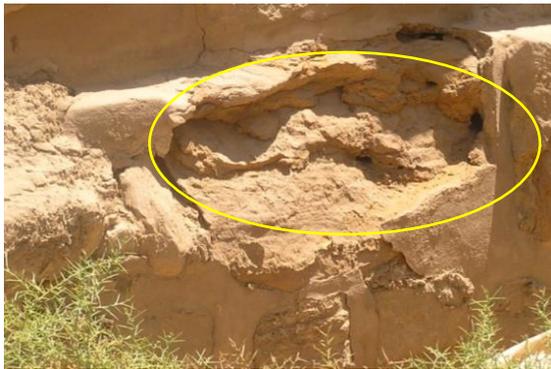
A hard crust appears because of water movement via the pores and interacts with the binder, and the outcomes deposit on the surface and may mix with dust, dirt, and aerosols, forming the crust. Below the crust is a weak layer resulting from the continuous loss of the binder between the granules. This phenomenon is called stone bleeding [4], fig.(1).

Figure (1) Shows **a.** a gate of Amenhotep Temple (middle), **b.** a block in the entrance of the Obet Temple

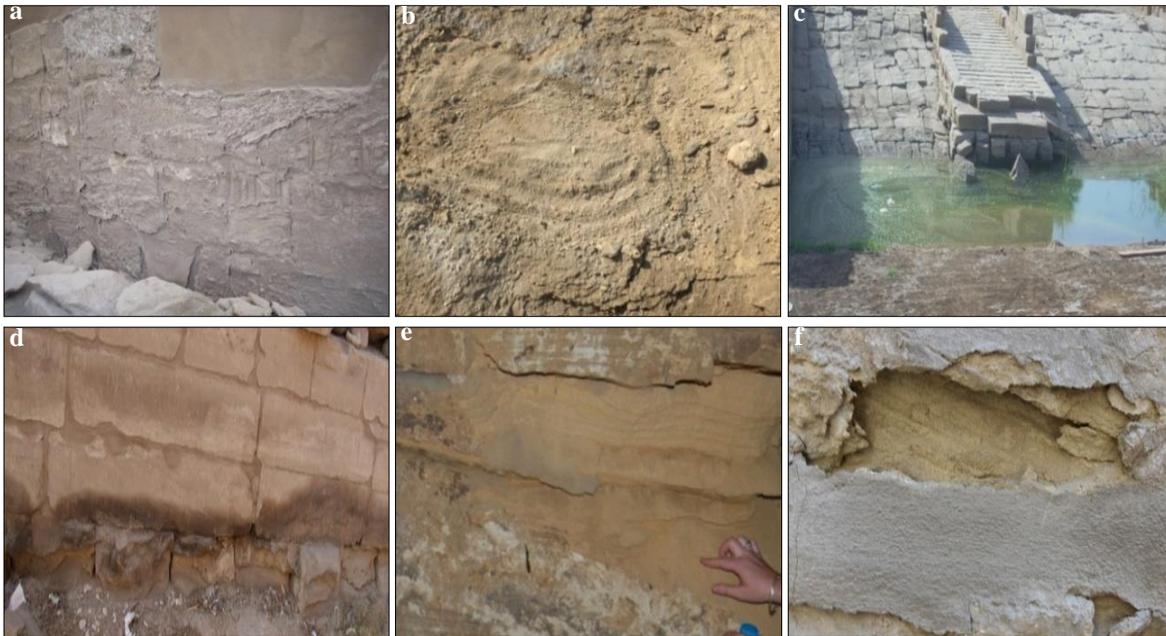
Figure (2) Shows some occurring reasons of stone bleeding affected the study areas **a.** depth of preparation layer of incoherent construction materials, **b.** salt efflorescence in some doorsteps, **c.** groundwater in the wall of the port below the entrance of Karnak temples, **d.** humidity and its effect on the Taharqa temple, **f.** improper restoration using black cement in the southern part of Hall two of the Holy of Holies, Temple of Ramesses III, Karnak.

- *) Incoherent construction materials and different mineral structures of the stone cause different expansion and shrinkage ratios [5], weaken the bonding between granules, and decay the stone compounds with the help of deterioration factors [6], fig.(2-a).
- *) Salt crystallization causes the disintegration of granules, loss of the construction materials, cracks, and rupture [7]. Salts resulting from the use of black cement in the reinforcement operations, salts in

the wall of the monument, and the interaction with the surrounding environment [8], including heat and humidity in the case of rains rich in salt, cause stone bleeding because of water evaporation and the concentration of the salt solution in the stone, causing salt crystals with increased size in the pores. Consequently, the internal pressure affects the stone components and the binding material. Droppings of birds [9] and animals loaded with salt motivate stone bleeding. Furthermore, groundwater salts play a significant role in stone deterioration, especially in the Karnak Temple [10]. Deterioration resulting from salt crystallization depends largely on the salt type, stone resistance, and pores. Physical weathering, including salt crystallization, mainly affects the sandstone's degradation, causing differences in the texture and petrophysical properties of the stone, which affect the stone and result in stone bleeding in the hard outer crust and the inner components [11]. Moreover, compressive strength, porosity weight loss, salt crystallization, mineral structure, and type of the binding material affect the sandstone [12]. Heat variations and pressures on the stone result, in addition to, the recrystallization of fine salt layers may cause shear stress, which can cause stone corrosion [13], fig. (2-b).

- *) Groundwater is an important factor in affecting stone bleeding because it causes size expansion and bristle of mud minerals [14], resulting in breaking the bonds between the granules and the decay of the stone components. It comes from many sources, such as agriculture, rains, and fluids [15], especially sewage rich in salts with differences in the rates of heat and humidity. Water rises due to the capillary system, with salts, including C, NO₃, SO₄, Mg, Ca, K, and Na, fig.(2-c).

- *) Relative humidity dissolves salts in the stone and moves the salt solution to the surface, causing water evaporation and salt efflorescence, which, in turn, causes pressures, decay of the stone, and forming a hard crust because of the dissolution of the binder. The pores are filled with water, which is taken to the surface. Frequent evaporation causes a tight layer and the loss of the binder in the walls. Scratching this layer causes the bleeding of stone, fig. (2-d).
- *) Temperature fluctuations cause changes from dry to wet conditions, causing severe damage, disintegrating granules [16], and stone bleeding. Moreover, the color of the mineral affects the deterioration operations because dark minerals absorb more heat than the light minerals, causing granular disintegration [17], fig. (2-e).

- *) Improper restoration works [18], deteriorate the monument because of using improper materials and black cement, which have a harmful effect because of being saturated with saline water and reinforcement materials that have not penetrated the pores, deposited on the surface, and formed a layer. When this layer separates, it takes the patina layer and causes stone bleeding or completely disintegrates when they exposed to in witting followed by drying cycles [19], fig. (2-f). Some stones have high porosity, while others have low porosity. Sandstones with high porosity are affected by deterioration because porosity is one of the most important features affecting sandstones' deterioration [20].

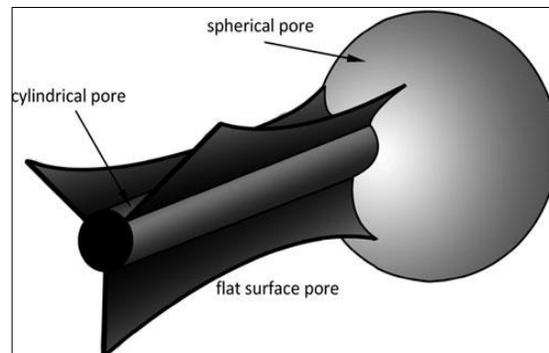
Figure (3) Shows the basic geometric shapes of the pores, especially in sandstone, (After, Bernabe, 1991) [31].

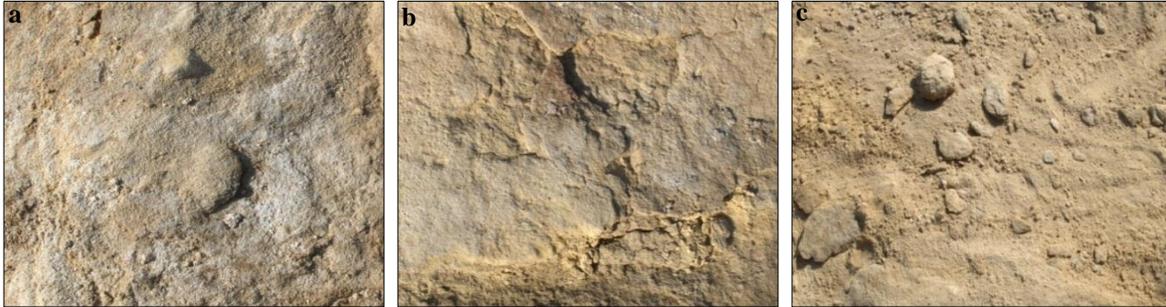
A hard crust is formed. Over time, a thick layer is formed, which deteriorates and deforms the aesthetic shape of the monument, making the stone below is very decayed, fragile, then, susceptible to disintegration

decomposition processes. When exposed to scratching, continuous stone bleeding takes place in the layer in the form of disintegrated granules like sand powder, fig. (4).

Figure (4) Shows the development stages of the stone bleeding; **a.** crust created, **b.** granular disintegration, **c.** stone bleeding.

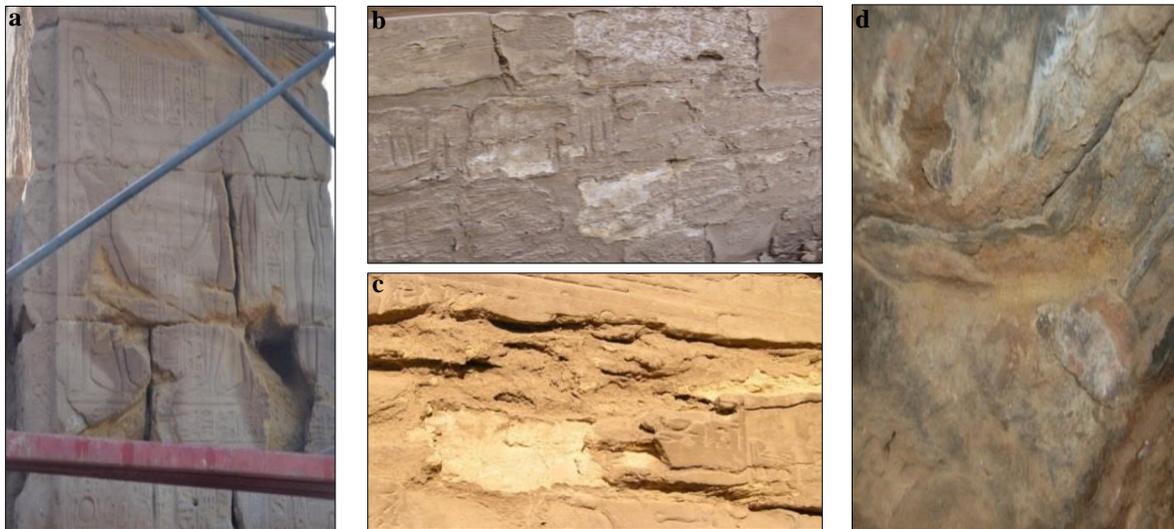
Stone bleeding was observed in several locations in the Karnak temples, mostly in the lower parts of the walls, because they are more prone to the effect of humidity or groundwater and salts (*the main causes of stone bleeding*). It also occurs near the inappropriate restoration works using very

hard black cement, which contains a high percentage of salts, such as the gate of the *Ptah temple, Taharqa temple, the columns of compartment in the Khonsu temple*, and some parts of *the Obet temple walls*. In addition to other many places in *Karnak area*, fig. (5)

Figure (5) Shows some locations of the bleeding in the symptom in some parts of Karnak temples; **a.** the entrance of *Ptah temple*, **b.**, *Taharqa temple*, **c.** eastern wall of the *Obet temple*, **d.** the cornices of *Khonsu's temple hall*.

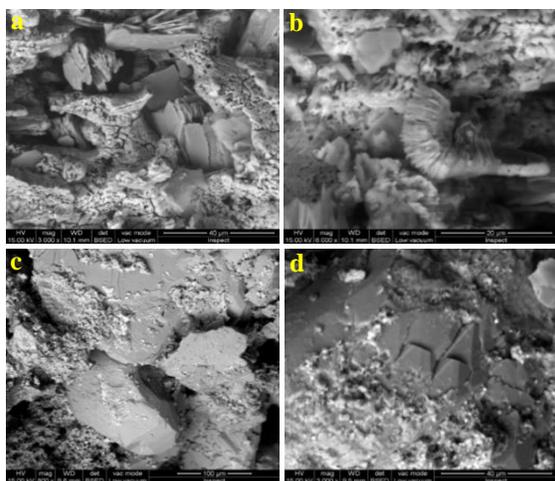
SEM investigations of the samples showed that their morphology contains quartz and silica. It also illustrates the different forms of deterioration such as kaolinite particles as a main weathering products, in addition to halite and thenardite as salts that led to some cracks and micro-fissures that resulted as a direct effect of stone bleeding, fig. (6).

Figure (6) Shows SEM photomicrograph; **a.** deterioration forms and kaolinite (3000x), **b.** NaCl within the cracks (6000x), **c.** Na₂SO₄ granule disintegration, **d.** some accumulated particles of weathering products (3000x).

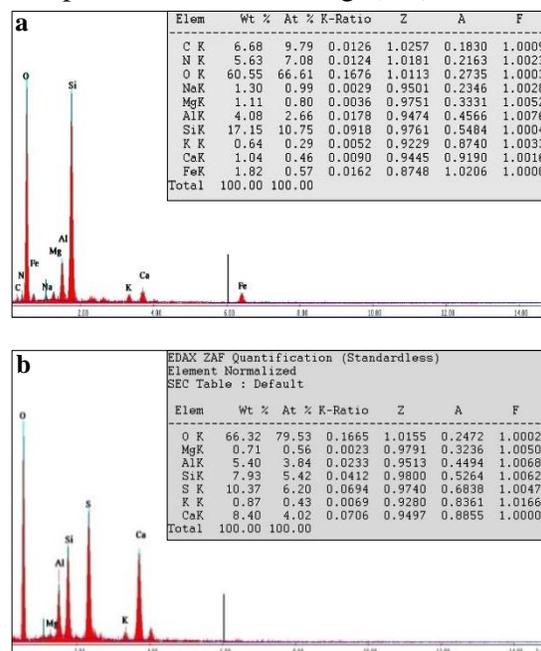
EDX analytical results of *Khonsu temple* sample showed a high percentage of **O** (60.55%), followed by **Si** (17.15%), **C** (6.68%), **N** (5.63%), **Fe** (1.82%), **Na** (1.30%), **Mg** (1.11%), and **Ca** (1.04%). It also showed secondary elements, such as **K**, fig. (7-a). The sample related to the *open courtyard* showed a high percentage of **O** (66.32%), followed by **S** (10.37%), **Ca** (8.40%), **Si** (7.93%), and **Al** (5.40%). It also showed secondary elements, such as **K** and **Mg**. Finally it illustrated that silicon is the main component of sandstone, fig. (7-b).

Figure (7) Shows EDX analysis of some affected samples in the study area; **a.** Khonsu temple, **b.** eastern wall of the Obet temple

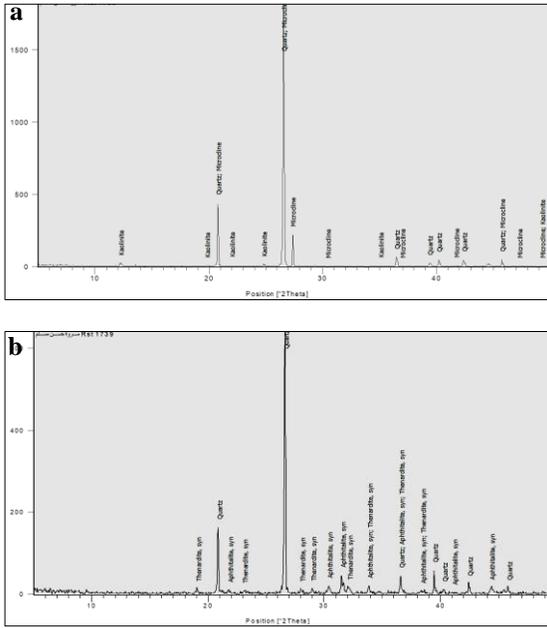
XRD results of the sample of the wall of Amenhotep II temple of showed that *quartz* is the main component, whereas *aphthitalite* and *thenardite* are impurities, fig. (8-a). Moreover, analytical results of the sample behind the great hypostyle hall illustrated that *quartz* as the main component, *microlite* as a secondary component, and *kaolinite* as an impurity, tab. (4) & fig. (8-b).

Figure (8) Shows the XRD pattern of samples; **a.** Amenhotep II Temple, **b.** great hypostyle hall.
