*Original article***ROLE ASSESSMENT OF BAT EXCRETIONS IN DEGRADATION OF PAINTED SURFACE FROM MOHAMED ALI'S PALACE, SUEZ, EGYPT**Bakr, A.¹ & Abd El Hafez, M.²¹Asses. Prof. Conservation dept., Faculty of Archaeology, Cairo Univ., Giza, Egypt²Asses. Lecture Conservation dept., Faculty of Archaeology, Cairo Univ., Giza, EgyptE-mail: amanymbakr@hotmail.com

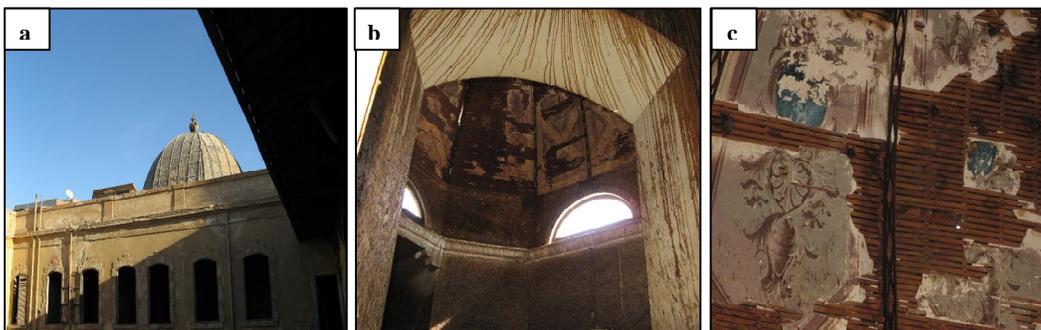
Empress Eugenie during her attendance the Suez Canal opening ceremony and watching the first performance of Opera Aida. During the rule of Mohamed Ali's family, a part of the palace was allocated to establish the second oldest religious court in Egypt during the Ottoman rule and it was opened in 1868. After the revolution of 1952, the palace was used by the governments as division of Suez security until 1980. Since that time the palace was abandoned and it became in very bad preservation state showing typical damages caused by humane gross negligence. Companioning of humane and environmental factors played an important role in destroying many of palace's architectural and ornamental elements, fig (1-b). Many parts of palace were inhabited with bats, most of them settled in the palace's dome, fig (1-c), since it is suitable structure for them. The large numbers of bats hanging from the

dome ceiling produce great amount of droppings (*faeces*) and urine which make this area very odiferous. Large areas of the painting layer are very fragile and they are completely detached from the

background wood constructions of the dome. Most the remains of the paintings were obliterated under the bats droppings.

Figure (1) **a** the dome of Mohamed Ali's palace from outside, **b** the inside of the dome room, **c** details from the wall paintings decorated the ceiling of the dome (some bats are seen in the picture)

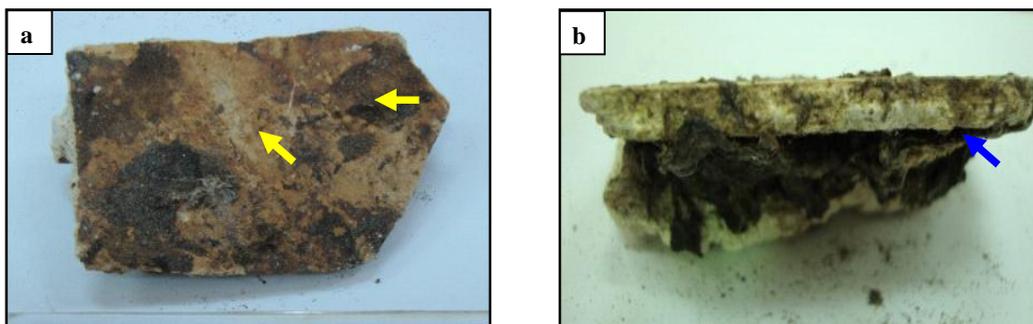
The preliminary observation of the collected samples by (OLM) revealed that the yellowish surfaces of the painting within dark brown stains are observed. It was difficult to distinguish the original color of the surface under the accumulated stains.

Under this layer, the main background white layer can be seen. The thickness of this layer ranges from 10 mm to 15 mm. large amounts of bats guano accumulated directly on the back side of this layer, all of these features are shown in, fig (2-a, b).

Figure (2) **a** & **b** the studied samples contains different deterioration form

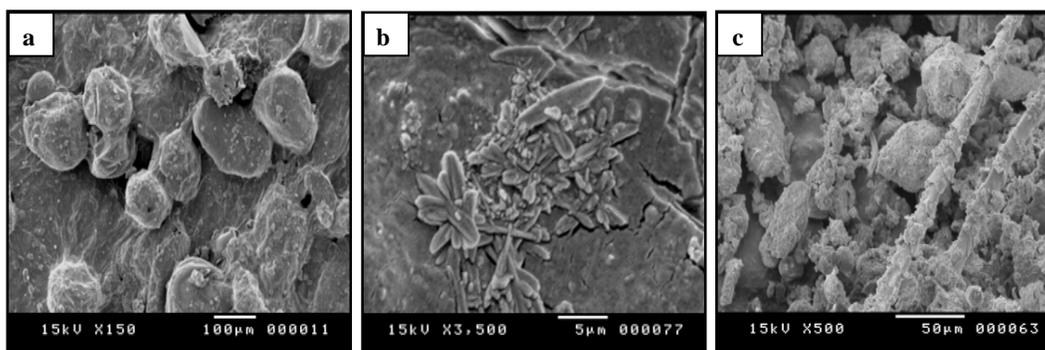
SEM-EDX examination was undertaken of the yellowish surface of the painting containing dark brown stains. The SEM observation of the dark brown stain reveals a polymeric like morphology within which are dispersed spherical coarse grains, fig. (3-a & b). The main elemental composition of these stains are listed in tab. (1), where, the total EDX analysis showed that silicon (Si), calcium (Ca) and aluminum (Al) are the dominant elements in the sample. Significant amounts of sulphur (S), potassium (K) and magnesium (Mg) were

recorded. Sodium (Na), chlorine (Cl), Copper (Cu), Zinc (Zn), phosphor (P) and iron (Fe) represent the minor elements in the sample. The morphological observation and the elemental composition of this stain indicate the presence of some salts that are related to normal chemical composition of the blood with accumulated dust particles. Moreover, the SEM observation of the yellow surface after removing the dark stain reveals the disintegrated smooth surface within which are dispersed aggregates of columnar and flaky

crystals. EDX analysis of this sample showed that S, Cl, Ca, Si and K are the major elements in the studied area. Considerable amounts of Na, P, Al and Mg were recorded. The observed crystal features and the elemental composition suggested it is a mixture of gypsum and various kinds of potassium, chlorine and phosphate salts. Furthermore, SEM-EDX, examination results of the undertaken surface layer contacted directly with bat guano showed interesting morphologies.

The surface reveals a generally coarse morphology with presence of parts of undigested insects and bats hairs, fig (3-c). The EDX microanalysis of this layer listed in tab. (1) showed that Ca, S, Si, Na, K and P are the major elements in the sample. Considerable amounts of Cl and Mg were also recorded. The significant detected amounts of P and K in this sample are probably related to the direct contact of this layer with bat guano.

Figure (3) **a**, **b** & **c** SEM images of the selected areas from the studied samples

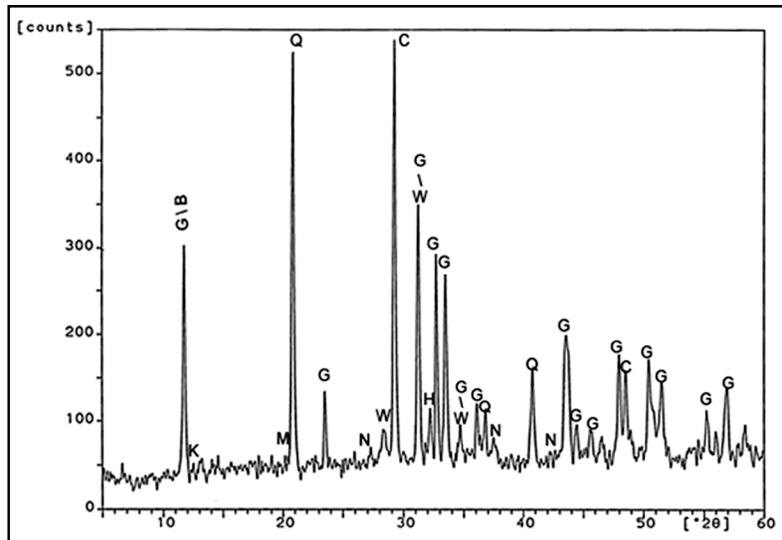
As shown in fig. (4), XRD analysis of the yellowish painting layer in direct contact with bat guano showed the presence of gypsum ($\text{CaSO}_4 \cdot 2\text{H}_2\text{O}$) as a main component. Smaller amount of calcite (CaCO_3) and quartz (SiO_2) were also detected. These minerals most probably represent in the main

compositions of the painted layer. Small amount of halite (NaCl), clay minerals (Kaolinite and Montmorillonite) were recorded, and finally some phosphate minerals are detected, they are:

- Brushite ($\text{CaH}(\text{PO}_4) \cdot 2\text{H}_2\text{O}$)
- Newberyite ($\text{MgHPO}_4 \cdot 3\text{H}_2\text{O}$)
- Whitlockite ($\text{Ca}_9(\text{Mg},\text{Fe})[\text{PO}_3\text{OH}/(\text{PO}_4)_6]$)

Figure (4) XRD patterns of the studied sample. G= gypsum, B= brushite, Q= quartz, N= newberyite, W= whitlockite, K= kaolinite, M= montmrrillonite and H= halite

SEM-EDX and XRD results of the painted surface showed that gypsum ($\text{CaSO}_4 \cdot 2\text{H}_2\text{O}$) is the main component of this layer with smaller amounts of calcite (CaCO_3) and quartz (SiO_2). The surface morphology, the observed crystal features and the elemental composition (Ca, S, Si, Na, K, P, Cl and Mg) of the studied samples indicate the presence of some salts that most probably related to the normal chemical composition of the blood and bat guano accumulated on the painted surface. Furthermore, XRD analysis indicate the presence of Halite (NaCl) and Phosphate minerals such as Brushite ($\text{Ca H}(\text{PO}_4) \cdot 2\text{H}_2\text{O}$), Whitlockite ($\text{Ca}_9(\text{Mg, Fe})[\text{PO}_3\text{OH} / (\text{PO}_4)_6]$) and Newberyite $\text{MgHPO}_4 \cdot 3\text{H}_2\text{O}$. The phosphates salts detected in the sample are related to bat guano accumulated on the painted surface. The companionship of phosphate and sulfates minerals with the presence of bats guano was mentioned in many studies of the stone deterioration by salt efflorescence [15] [16] [17] [18]. Bat guano consists mostly of excrement with undigested part of insects and it contains significant amounts of phosphorus, potassium and nitrogen. It is also rich in a wide range of elements such as sulphur, calcium, sodium, zinc, iron, and magnesium [19]. The organic compounds in the excrement containing sulphur, phosphorous and nitrogen may form sulphuric, phosphoric and nitric acids after decomposition and oxidation. These acids react with base elements in the substrata on which it deposit to form their corresponding salts, sulphates, phosphates and nitrates. Potassium and nitrates compounds could not be detected in many cases because of their soluble properties. In our case, no potassium mineral was detected although potassium element was recorded in the EDX analysis.

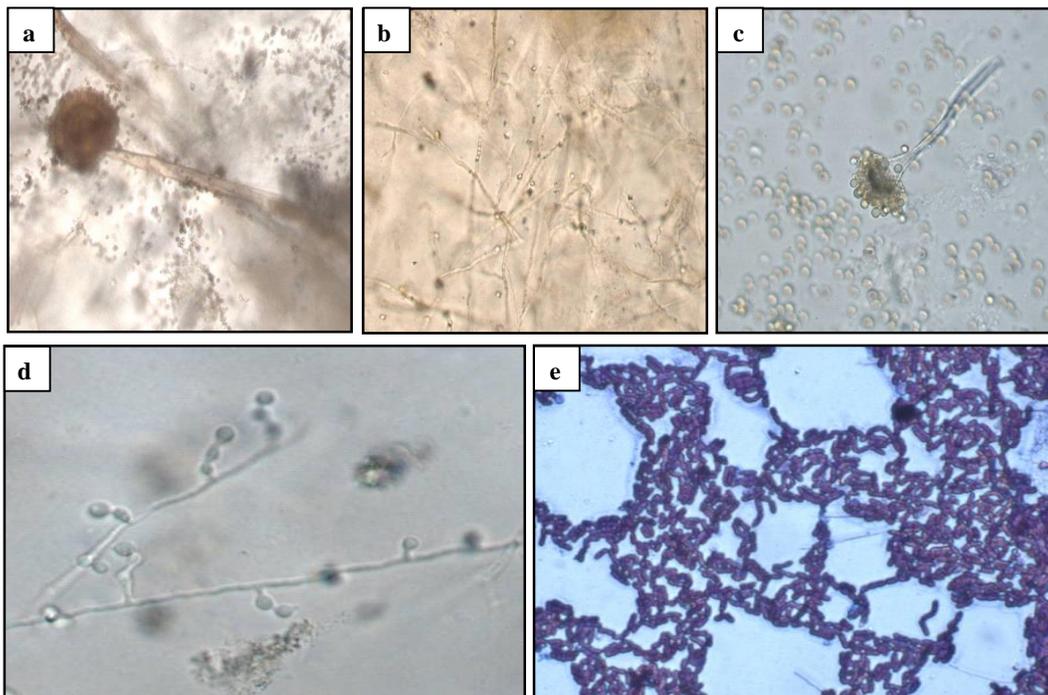
Cultures of the studied samples show a good growth of microorganisms mass. The OLM examination showed the presence of four kinds of fungi and one kind of bacteria. *Aspergillus niger*, *Aspergillus flavus* and *Acremonium cerealis* grew on the Dox's agar media while *Mortierella subtilissima* grew on

modified Dox's agar. G+ve *Bacillus* sp. (Mono-Dibble- strepto bacillus) grew on nutrient agar media, fig. (5-a, b, c, d). Actually, by using the current types of culture media, we were able to cultivate only a small part of the whole microbial population.

Figure (4) microphotographs of isolated fungi and bacteria, (a) *Aspergillus niger*, (b) *Acremonium cerealis*, (c) *Aspergillus flavus* (d) *Mortierella subtilissima*, (e) G+ve *Bacillus* sp. (Mono-Dibble- strepto bacillus).

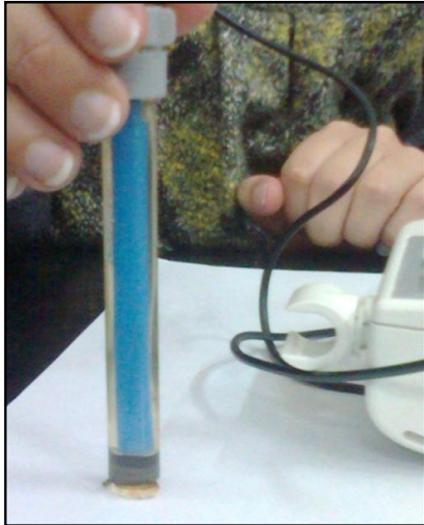
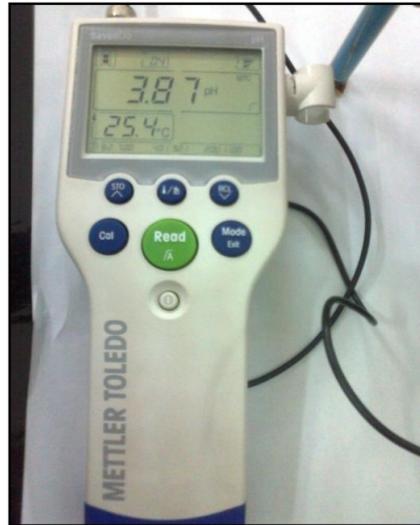
Figure (5) pH measurement of the studied samples

Within the same context, the complex chemical composition of the studied samples containing bats droppings (guano), urine and dry blood indicate that a wide spectrum of microorganisms should be present. Steele, D. [20] reported that the chemical analysis of bat guano is quite similar to an elemental analysis of the manufactured bacteriological growth media used in microbiology laboratories throughout the world. In recent years some studies concerned with the environment of bat-inhabited caves reveals the presence of a wide range of microbial activities that is related to the presence of bat guano [21] [22] [23]. *Aspergillus sp.* and *Acremonium sp.* had a casual distribution on the archaeological stone surface and wall paintings under various suitable conditions [24] [25]. The presence of *Mortierella sp.* was always associated with bat guano [26]. The ability of these organisms to cause serious damage to many kinds of stone structures has been well established [27] [28]. It was estimated that biological weathering is 100–1000 times greater than inorganic weathering [6]. The accumulation of bat guano on the historical stone structures create very encouraging conditions for millions of micro-organisms (bacteria, fungi and actinomycetes) which decompose the organic matter, transforming it into different organic acids, enzymes, antibiotics and other organic compounds. This decomposition process means that bat guano is acidic all the time. In our case, the pH measurement of the yellowish painting layer contacted directly with bat guano revealed the pH value ranging from 4 to 4.6. Figure (5) confirming the acidification of the accumulated bat guano on the painting layer. The acidic attack of the stone structure is one of the main mechanisms of biodeterioration. In addition to the acidity effect of bat

guano, bat urine (which is about 70% urea) has very strong alkaline effect and it can cause pitting, staining or etching of painted surfaces. The results of this study showed that the bat
