Original article

**RESTORATION AND PRESERVATION OF THE WOODEN CEILING OF  
AL-ASHRAF QAYTBAY MADRESSA, CAIRO – EGYPT**

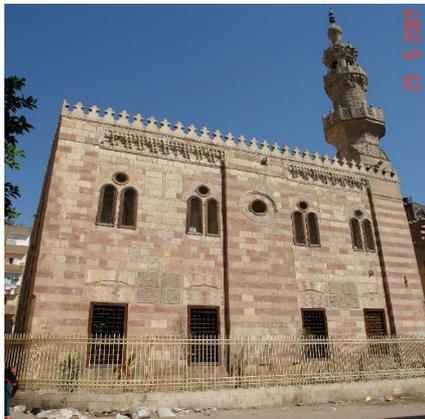
Figure (1) **a** Madrassa of Sultan al Ashraf Qaytbay **b** plane of the ceiling of the Madrassa

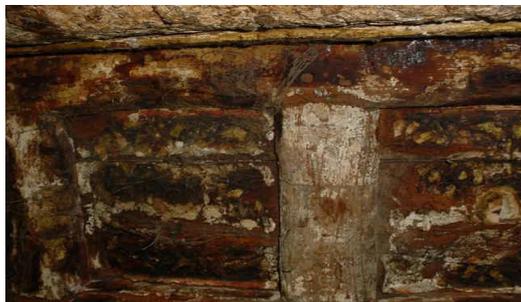
Figure (3) the formation of detachments and cracks of the wood ceiling due to temperature and humidity changes.

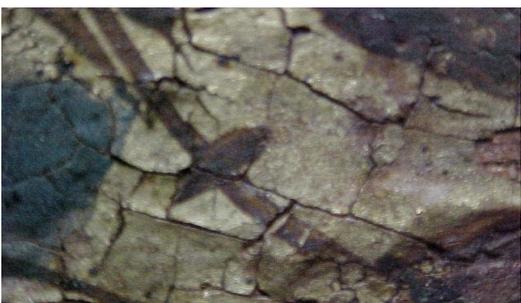
Figure (5) cracks and micro cracks at the preparation layer, paint layer, wooden support and falling of pigments.

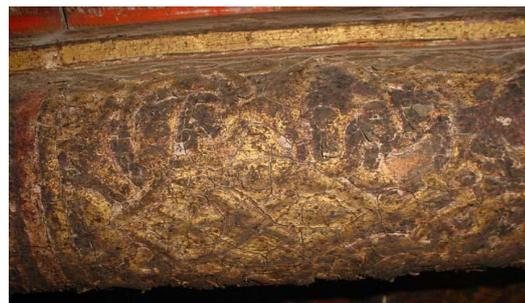
Figure (6) the painting covered with numerous layers of dirties, stains, insects remains and numerous cobweb nests.

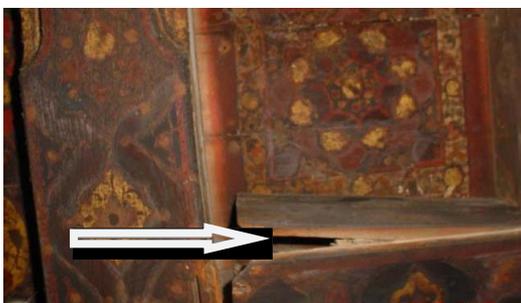
Figure (7) the warps, twists and shape distortions of the ceiling.

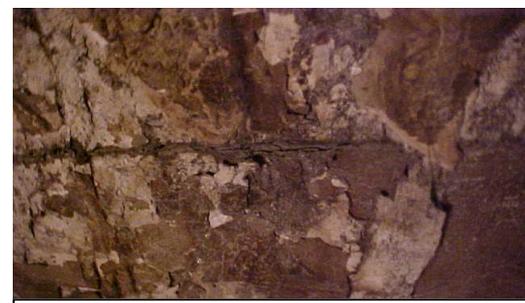
ceiling of the madrassa of Al Al-ashraf Qaytbay had been damaged and loss of many architectural elements as a result of biological attack. Many birds lived in this building as, birds, kites, crows, pigeons. This had their nests and houses the largest impact damage in those places, as their droppings have led to damage elements, which fell out and there wastes make a good feeds for micro-organisms such as fungi and bacteria. In addition, there were animals such as mouses and rats, which have made many of the tunnels within the elements of the ceiling impact, causing damage and the collapse of many of these elements. This effect was also to serve injury and bats and their droppings, which led to damage to decorative items, and resulted in blood resulting from the process of menstruation, as well as urine to remove the layers of colors and distortion of architectural elements, fig.(8). - Crumbing in some parts of plaster were noticed. Gypsum mortar is less durable than lime mortar, as it is more soluble when exposed to water. However, at high temperatures, it dehydrates if the relative humidity is very low, that leads to crumble and decompose, fig. (9). In other cases the medium disintegrates, resulting in a loss of cohesion and powdering of the paint layer. - The microbiological infestation can be seen in varying concentrations causing discoloration often associated with detachment of the paint layer, fig. (10). Because wood is biological origin, wood is susceptible to deterioration by a variety of biotic agents. Physical, chemical and biological factors interact with wood including changes both in its compositional and structural characteristic. The intensity of bio-deterioration depends on the type of organic involved the wood species and environmental parameters (temperature and relative humidity). Warm and humid condition is extremely favorable to the growth of most organisms, thereby increasing wood's vulnerability [9]. Most deterioration problems in wood are caused by fungi, and are a direct result of

Figure (8) loss of some architectural elements as a result of biological attack at the ceiling **a** bat droppings **b** extracts of birds **c** Bees nests

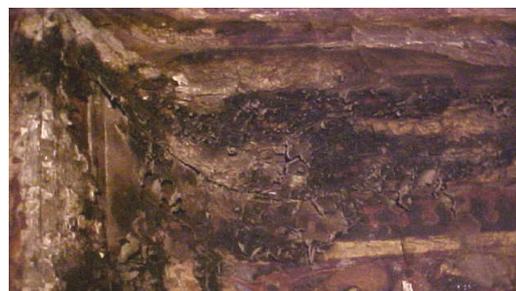
Figure (10) microbiological infestation causing discoloration often associated with detachment of the paint layer.

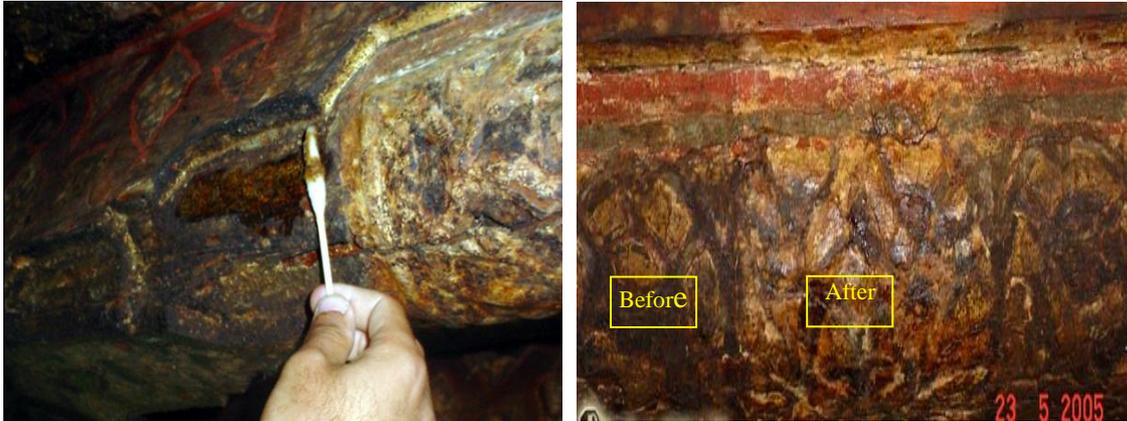
Figure (18) the chemical cleaning of the painted ceiling.

pieces of wood using scalpels and engraving tools with extreme care.  
**Chemical cleaning:** This work also involved the removal of tarnished varnish, also deep cleaning of exposed wood, principally where fungus infestation and rotted wood could be detected with the application of solvents. Several chemical solvents were applied for cleaning. The trichloroethylene and Xylene gave good results in removing the wax and deteriorated varnishes. Also a mixture of Acetone, methanol and Ammonia solution gave a good result on excretes of accumulation of residue of insects and birds. Di-methyl formamide was used also to remove the black color at the wood and painting which was produced from pervious fault restoration, fig. 18 (a, b) .

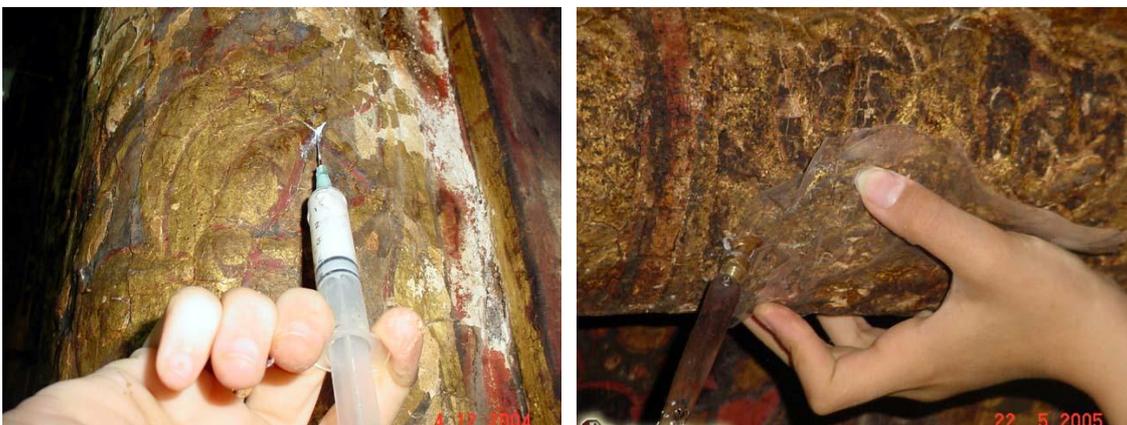
Figure (19) the fixation and consolidation of the paint layer.

The pigment and the painting layers lost its adhesion to the support in many places of the ceiling (micro cracks, flaking, crumbing were observed). Primary fixation of separated paint layer flakes was done by using emulsion of 10% Primal AC33, 1.5 Paraloid B.72 in trichloroethylene for the end fixation and it is installed by pressing peels gently with small piece of cotton. Warm spatula was used, fig. 19 (a, b). Thermal spatula was used in installation of paint layer crust that is difficult to

address directly to the fragility of the cohesion and in case of the worst parts is plastic paper insulation and spatula are passed to the individual and the softening process and installation and without exposing skins and colored peels direct heat . For the installation and the strengthening of the pigment, which turned into a powder as a result of deterioration factors, Paraloid-B 72 concentration of 3% in acetone was used with aerosol spray-style plastic. This process was repeated several times until the paint surface was consolidated.

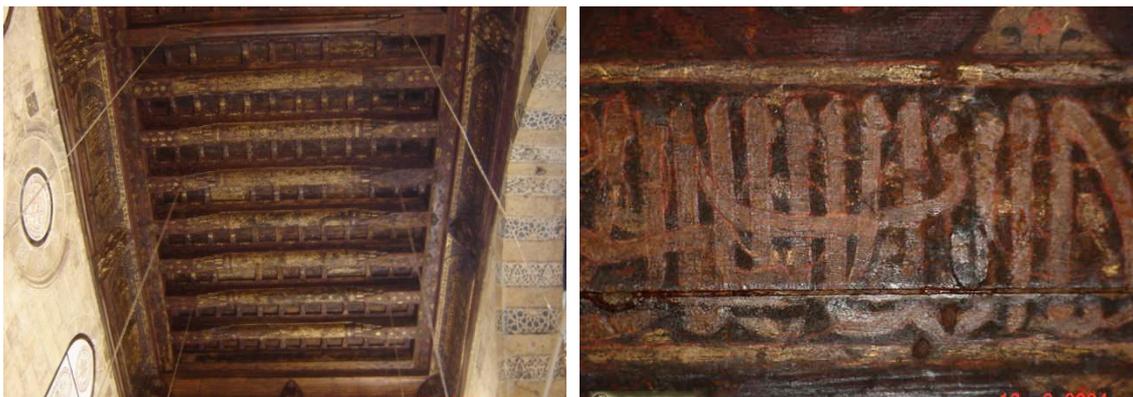
Figure (20) the painted ceiling of the Qaytbay madrasa after restoration.

After the completion of filling cracks and voids, the surface were smoothed by using different sizes of soft sandpaper to remove all products from the surface and prepared for the

work necessary frills color. At this stage used natural hair soft graduated sizes. In addition some oxides of color to give the mixture used the color of painting and wood, fig.. (21).
