## STUDY OF THE PAINTED DOME OF THE CHURCH OF ARCHANGEL GABRIEL, CAIRO

This study was carried out in preparation for the conservation of the oil painted dome of Archangel Gabriel church located at Haret El Saqqayeen in Abdeen (Cairo). Stratigraphic, chemical and environmental studies were conducted to examine the painting technique and to assess the conservation state of the dome. The dome was imaged using Multi-spectral imaging and samples were collected from representative areas. Cross-sections were investigated by the means of scanning electron microscopy coupled with dispersive energy of X-ray spectrometer (SEM-EDS) and stereo microscopy. Fourier transformed infrared spectroscopy (FTIR) and gas chromatography-mass spectroscopy (GC/MS) was employed for the identification of the paint medium. X-ray diffraction (XRD) and the colorimetric measurements were conducted for characterization the differences of hues between the original and non-original pigments. As a part of the study, the environment within the dome was measured with data loggers and gas sampling. The results showed that the painted dome dates back to two different periods. The older paintings were applied before 1907

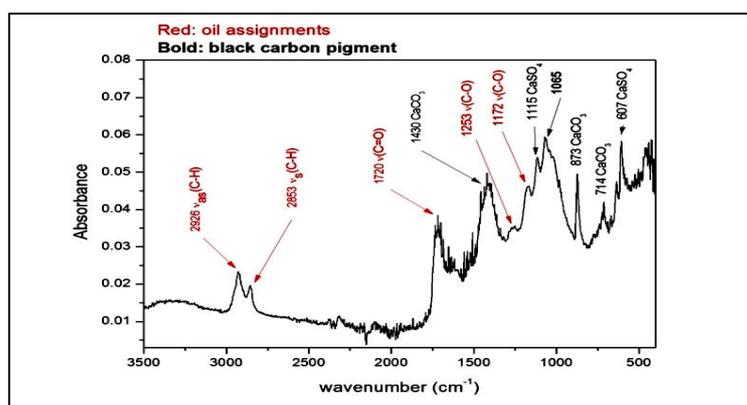
Walnut, poppy seed and linseed oils are common drying oils used in paintings since the medieval and modern times. FTIR spectrum collected from the black pigment sample indicated the presence of drying oil where the peaks of carbonyl groups recorded of C=O stretching band of ester at  $1720\text{cm}^{-1}$ , C-H absorption of fatty acids at  $2928\text{cm}^{-1}$  and  $2853\text{cm}^{-1}$ , fig. (7). Due to the simi-

ilarity of the drying oils spectra and the overlapping of calcium carbonate and sulfate peaks, further, GC/MS was carried out to determine the drying oil type based on the Palmitic (P) and Stearic (S) acids ratios. GC/MS of black pigment sample confirmed the presence of P/S (40.72/20.05) ratio of 2.03, close to that of linseed oil is  $(1.9 \pm 0.5)$  [19].

Figure (7) Shows FTIR spectrum of the drying oil medium
